## Corrective Action Report (8D)

| <b>2A</b> | Describe the Problem: Loose bottom lifting bracket screw at the customer site leading to the engine falling off and causing safety issue while lifting the engine. | | |
| | Lifting Bracket capscrew (LA 9172 option) | 3903990 | B6.7 300 HP-2023 |

## QUALITY ALERT

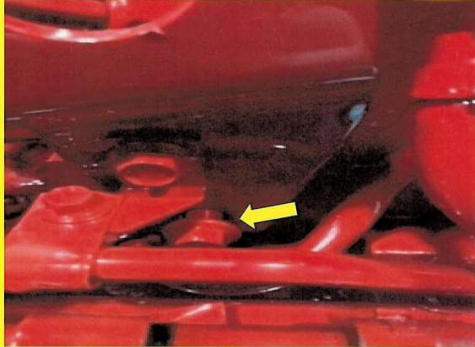
Due to recent (B.I.S.) Lifting Bracket Cap Screw not Torque causing a Catastrophic Damage to Engine.  
Operators that Run Critical Torque Station 4860:  
Operators Need to Verify Lifting Bracket Cap Screws are Torque .
