# Service Alert

| <b>Subject:</b><br>IN-VEHICLE NETWORK MALFUNCTION AND MASTER WARNING LIGHT ON. DTC U3000:04 STORED (DOES NOT APPLY TO 09-001/23) | Service Alert No.: SA-027/23 |

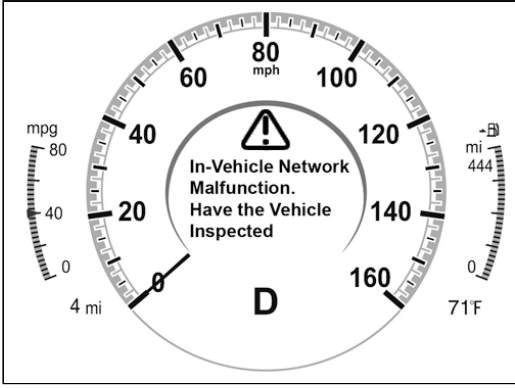
| In-Vehicle Network Malfunction error message | |
| Master Warning light ON. | |
| Connected Vehicle Reception Icon shows "X" | |
| DTC U3000:04 (Telematics communication unit internal malfunction) stored. | |

1. Verify customer concern.
2. Document DTC's stored on the repair order.
3. Check [eMDCS](#) for CSP04 status.

5. Disconnect battery for 1 hour.

6. Connect battery.

8. Clear DTC.

9. Check TCU software version. Go to MGSS -> Infotainment/TCU -> [Telematics Control Unit \(TCU\) Updates](#). and update the [TCU software](#) if MGSS has a newer version available.
