Subject: TELEMATICS COMMUNICATION UNIT (TCU) ACTIVATION PROCEDURE	Service Alert No.: SA-025/23
	Last Issued : 04/21/2023

2019-2022 Mazda3
2020-2022 CX-30
2021-2022 CX-5
2021-2022 CX-9
2022 MX-30
2023 CX-50

DESCRIPTION

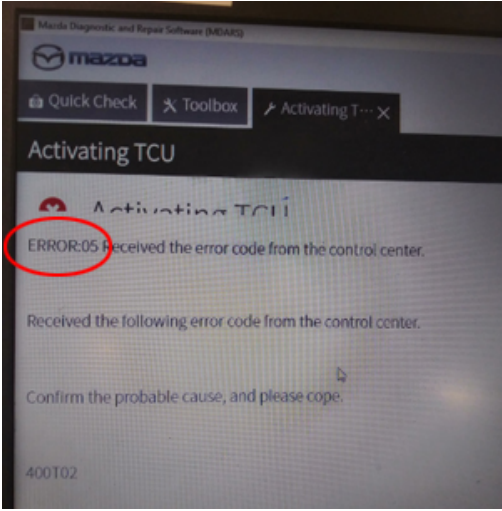
ERROR:05	Error code 400t02

- If DTC U2050:55-TCU (Activation of remote control not implemented) is stored, go to TSB [09-013/20 - DTC U2050:55 STORED AFTER REPLACING OR REPROGRAMMING TCU](#).
- If the TCU was not replaced and MDARS shows error code 400t02 and/or ERROR:05, TCU activation was previously completed. Ignore these errors as TCU activation is not required.

<p>The screenshot shows the 'Activating TCU' screen in the Mazda Diagnostic and Repair Software (MDARS). A red circle highlights the text: 'ERROR:05 received the error code from the control center.' Below this, it says 'Received the following error code from the control center.' and 'Confirm the probable cause, and please cope.' The error code '400T02' is visible at the bottom left of the screen.</p>

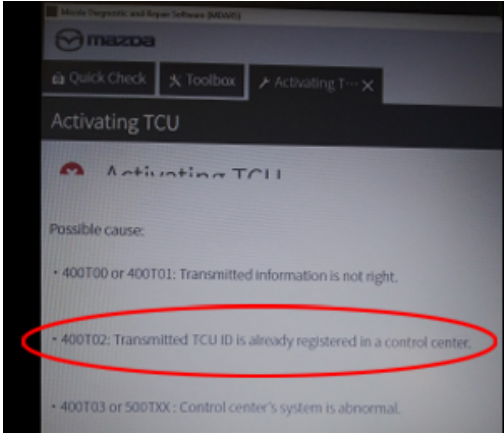
<p>The screenshot shows the 'Activating TCU' screen in the Mazda Diagnostic and Repair Software (MDARS). Under the 'Possible cause:' section, a list of error codes is displayed. A red circle highlights the entry: '- 400T02: Transmitted TCU ID is already registered in a control center.' Other causes listed include '400T00 or 400T01: Transmitted information is not right.' and '400T03 or 500TXX: Control center's system is abnormal.'</p>
