TECHNICAL SERVICE BULLETIN

Classification: AN19-069C	Reference: NTB20-002C	Date: April 3, 2023
------------------------------	--------------------------	------------------------

2019 SENTRA; STEERING WHEEL AUDIO SWITCHES INTERMITTENTLY INOPERATIVE

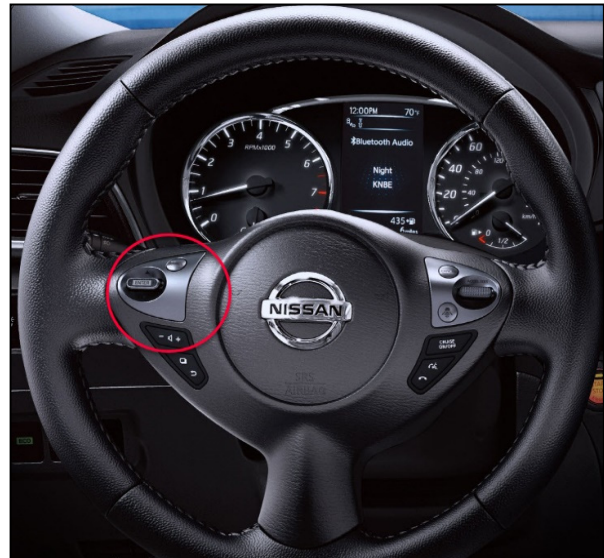
Figure 1

The steering wheel audio switches
(Figure 1) are intermittently inoperative.

Update the infotainment software.

- Refer to NTB23-018 to check, obtain, and install the latest AV Control Unit software version and for claims information.
