# Service Bulletin

Bulletin No.: 23-NA-027

**Subject: Poor Engine Performance, Engine Misfires, Malfunction Indicator Lamp (MIL) Illuminated - DTC P0201, P0202, P0203, P0204, P0205, P0206, P0207, P0208, P0300, P0301, P0302, P0303, P0304, P0305, P0306, P0307, and/or P0308 Set**

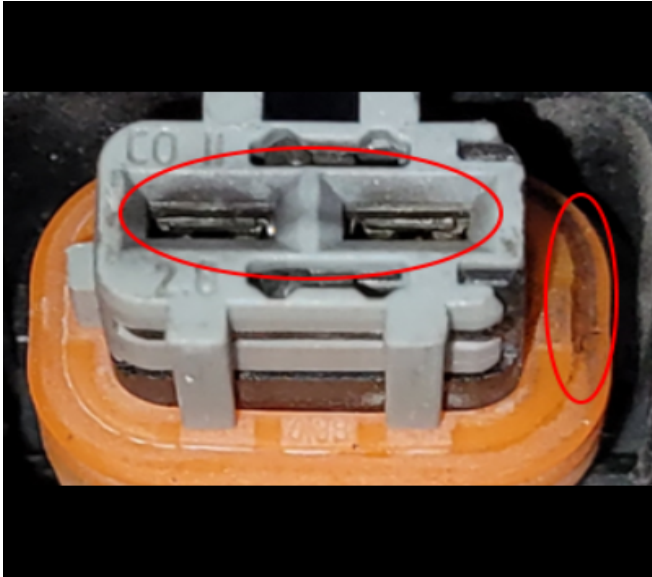
6279590

1. Using Diagnostic Test Probe J-35616-35 (VT), test all the electrical connectors. Refer to *Probing Electrical Connectors in SI*.
  - ⇒ While testing these connectors, examine the connector for indications of fretting or black powder on the connector or connector seal as shown in the graphic above.
2. If any connectors fail the probe test or the visual inspection, replace that connector. Refer to *Wire to Wire Repair in SI*.

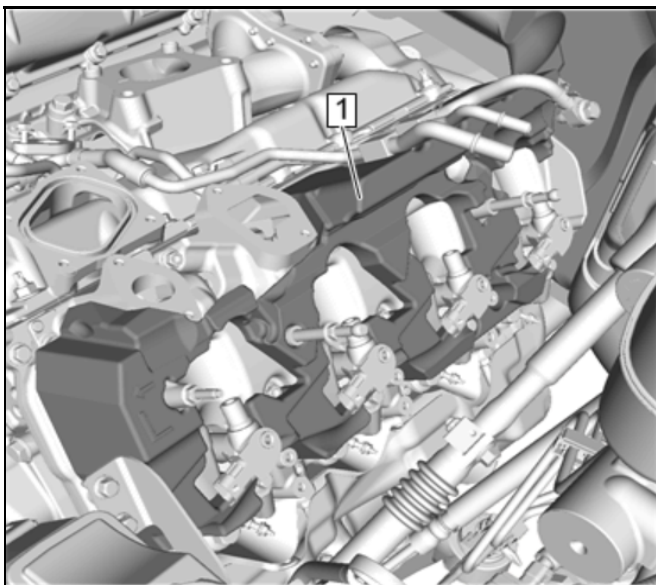
4599048

**Note:** Examine the underside of the deadener (1) for evidence of wire contact.

5. Prior to installing the deadener, verify that the wire routing doesn't come into contact with said deadener.
