Service Bulletin

Bulletin No.: 23-NA-074

Subject: Service Engine Soon (SES), Reduced Power, Service Brake, Reduced Steering and/or Stabilitrack Message Illuminated on Driver Information Center (DIC), DTCs P0232, P023F, P0641, P0651, P06A3, P0697, P07BE, P1000, P1009, P2535, P129D, P12A6, P12A8, P2635, P3051, P3052, P3055, P3056, P305B, U0074, U0077, U0121, U0131, U0151, U0415, U0420, U0672, U111A, U18A2, U18C6, U18D2, U2502, U2616 Set

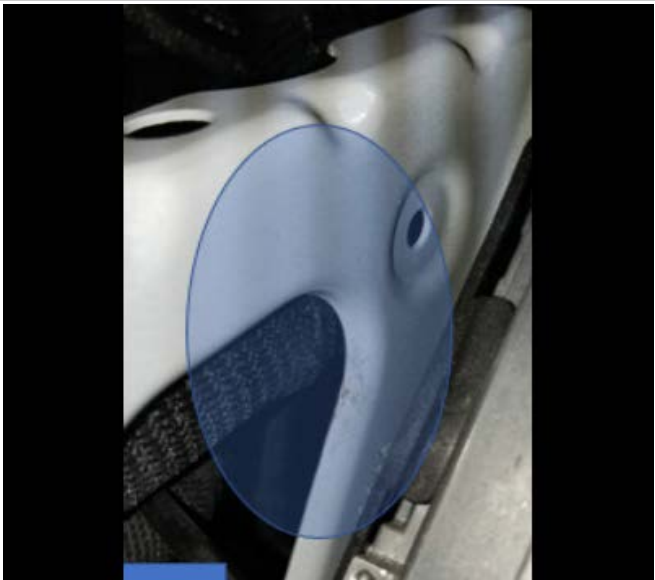
5874841

This condition may be caused by wire chafing on the battery tray support bracket.
