# TECHNICAL SERVICE BULLETIN

Classification: DA22-008A	Reference: NTB23-011A	Date: April 19, 2023
------------------------------	--------------------------	-------------------------

## "FORWARD DRIVING AIDS BLOCKED" MESSAGE ON INSTRUMENT PANEL WITH DTC C2582-97 STORED IN LASER/RADAR CONTROL UNIT

**APPLIED VEHICLES:** 2021-2023 Rogue (T33)

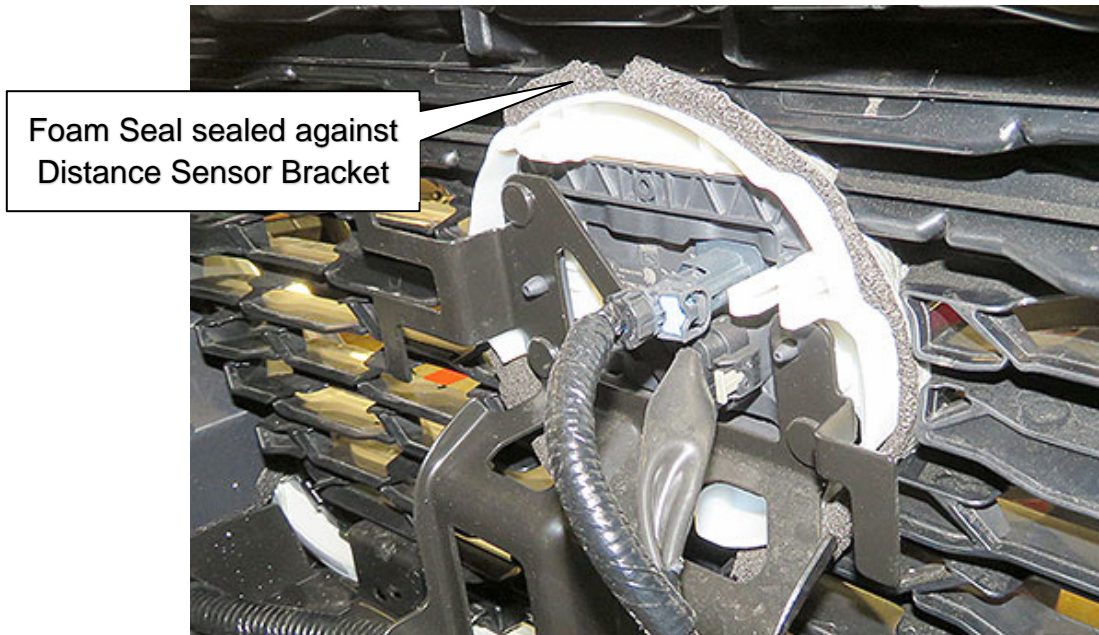
Figure 10

Foam Seal sealed against  
Distance Sensor Bracket

9. Reinstall the Front Grille.
