# Service Bulletin

Bulletin No.: 21-NA-268

**Subject:** Information on Crank No Start or Extended Crank, Malfunction Indicator Lamp (MIL) Illuminated - DTC P0014, P0017, P0365 and/or P0366 Set

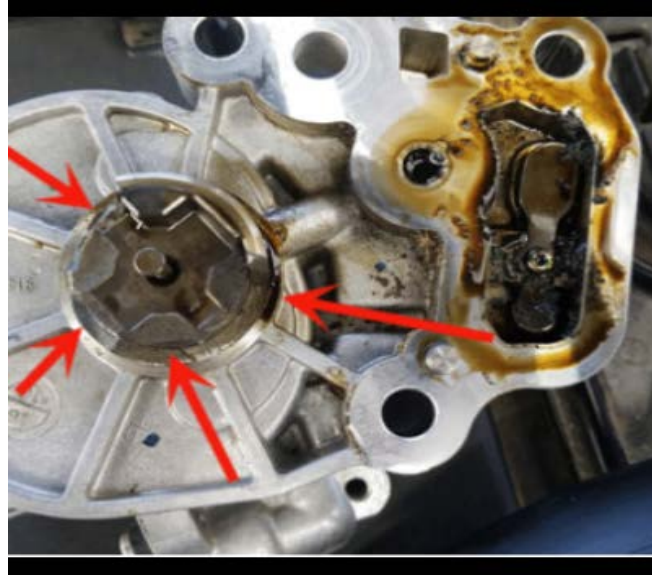
5921667

- ⇒ During disassembly, the vacuum pump drive lugs should also be inspected for damage (Photo above shows damaged vacuum pump drive lugs).

If you find the vacuum pump drive lugs are broken and/or the exhaust camshaft reluctor is out of position, then replacement of the exhaust camshaft and vacuum pump will be required.

**Note:** If needed, It will also be necessary to locate and remove the broken vacuum pump drive lugs and other metal debris during repairs.

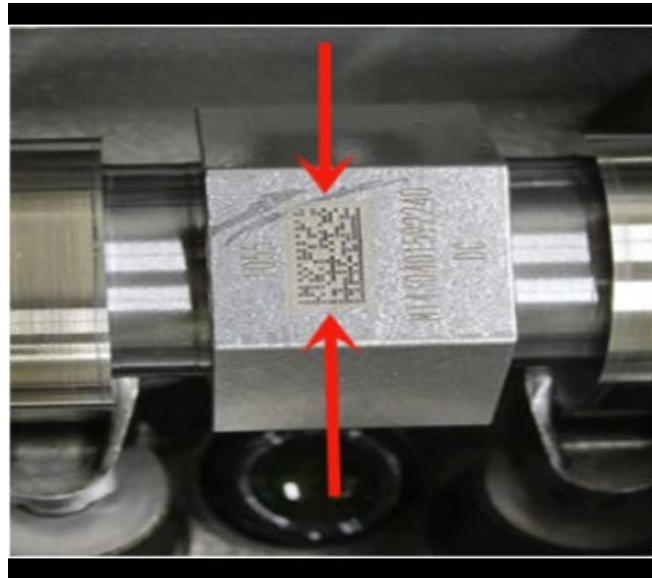
5921669

- ⇒ Rotate the exhaust camshaft to position the 2D matrix marking on the camshaft hex in the 12' o'clock position (Reference the graphic above for 2D marking).

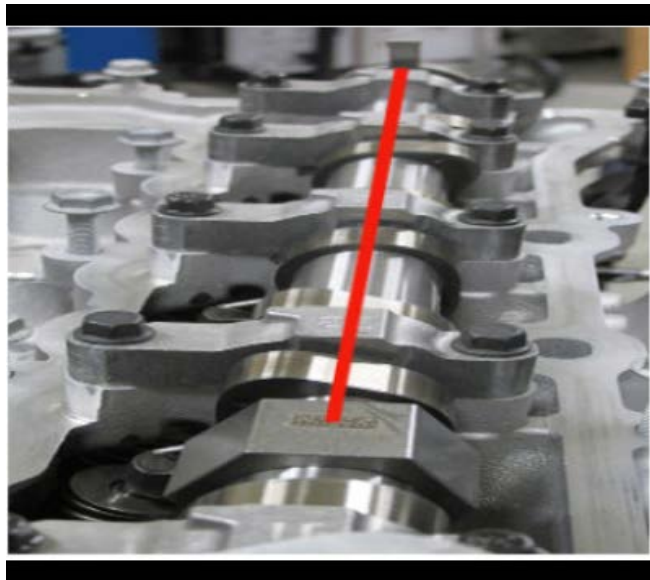
5921670

⇒ Once the exhaust camshaft 2D matrix has been positioned at 12' o'clock, verify the small tang located on the camshaft reluctor ring (Arrows below showing tang on reluctor) is in-line with the 2D matrix marking.

Also shown are additional reference points used to verify exhaust cam reluctor orientation to camshaft.

Proper relationship between the 2D matrix marking and the small tang on exhaust cam reluctor wheel.

**Important:** If the reluctor is out of phase, inspect the exhaust camshaft position actuator dowel pin for damage..
