| | | <b>Tesla, Inc.</b><br>Service Bulletin | | <b><i>Reseal Trunk Lid to Prevent Water Ingress</i></b> | |
| <b>SB-23-10-002</b><br>April 27, 2023 | | <b>R2</b> | | | |
| 2017 - 2023 | Model 3 | All | | Fremont | |

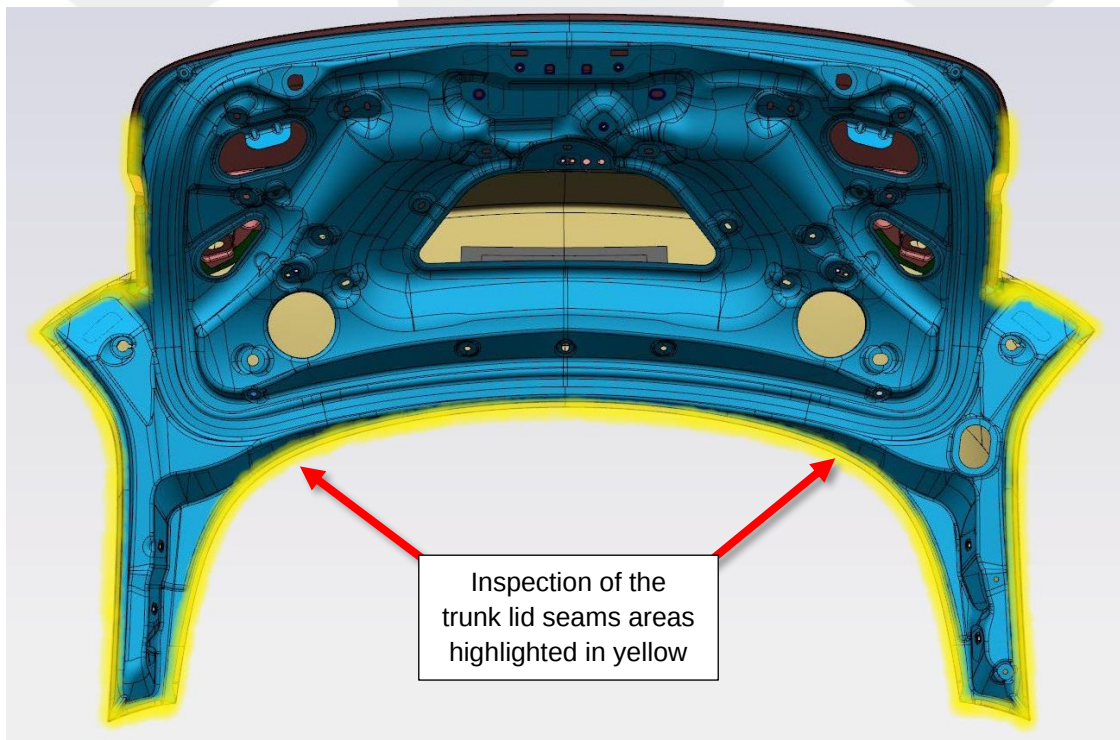
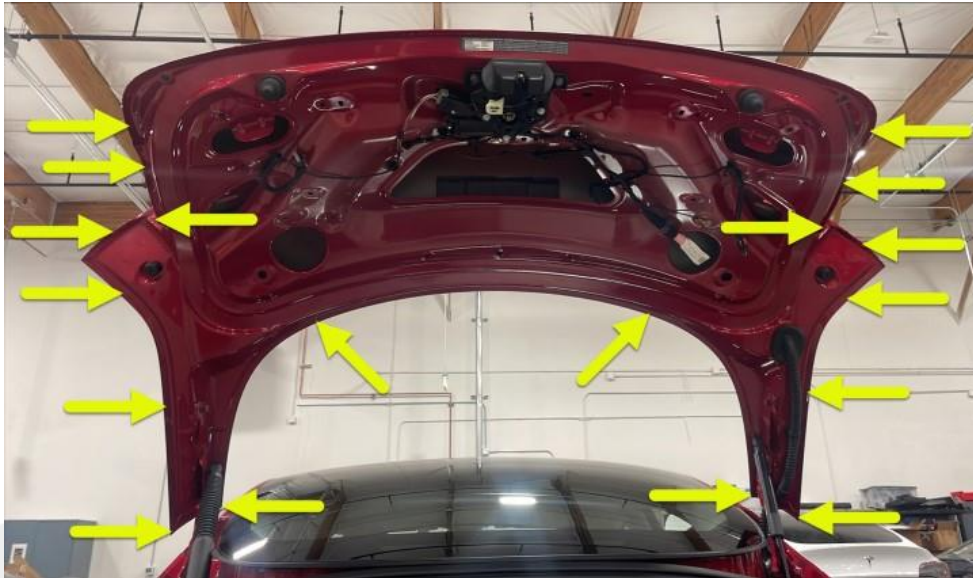
8. Inspect the trunk lid seams: Locate openings and pin holes in the highlighted areas (Figures 22–27).

11. Apply sealant **ONLY** on the openings and pin holes found during the inspection (Figures 34 and 35).

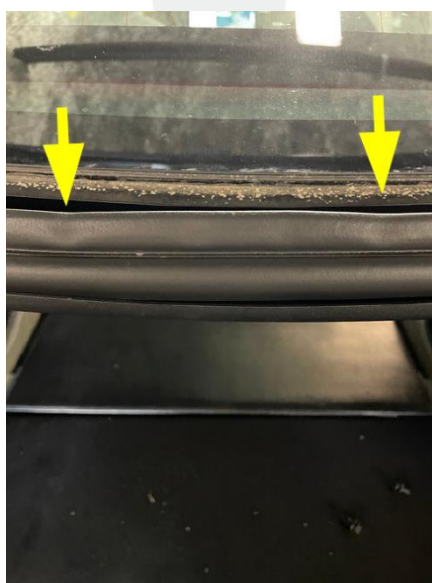
Figure 51

16. Inspect the overall condition of the trunk seal. If the trunk seal is compromised (Figure 51), replace the seal (refer to Service Manual procedure [11702002](#)).

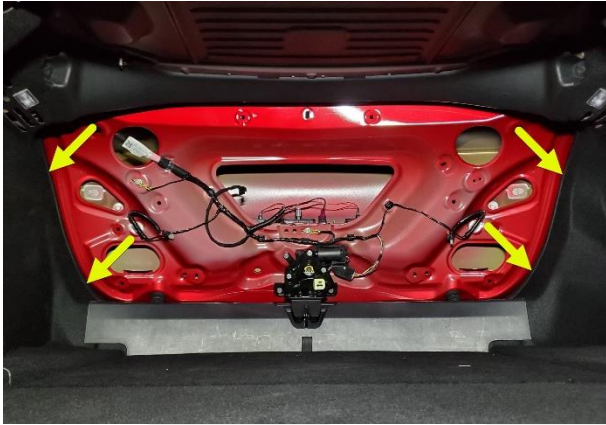
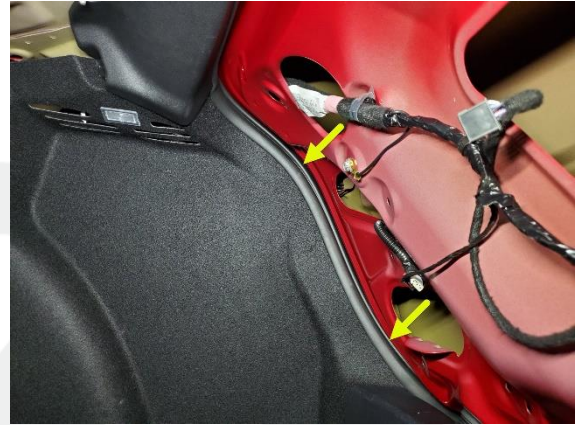
17. Close the trunk.
18. Verify that the trunk seal fully contacts the trunk lid and that there are no visible gaps (Figures 52 and 53).

**NOTE:** With assistance, shine a flashlight from the exterior and make sure no light is visible on the inside. If light is visible, then replace the trunk seal and repeat this step. If light is still visible after the replacement of the trunk seal, then perform trunk seal adjustment, as needed.
