Service Bulletin

Bulletin No.: 16-NA-405

Subject: Poor Engine Performance in Extremely Cold Weather Conditions, PCV Bypass Hose and Charge Air Cooler Icing for LUV Engines, Malfunction Indicator Lamp (MIL) Illuminated - DTC P0299, P0234, P2227, P00C7 Set

Brand:	Model:	Model Year:		VIN:		Engine:	Transmission:
		from	to	from	to		
Buick	Encore	2013	2021	Refer to Parts Information section for breakpoints.		1.4L (RPO LUV)	—
Chevrolet	Trax

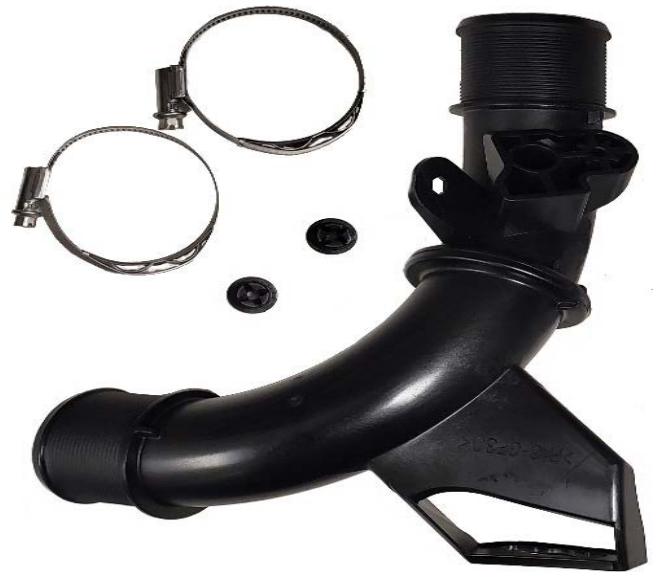
5410152

Note: The new elbow duct will have an estimated 45 degree mounting surface for the IAPT.

5. Install the new elbow duct onto the air hoses aligning the duct to the marks.
6. Install the band clamps.
7. Install the IAPT sensor.
8. Install the charge air cooler outlet air hose.
