Service Bulletin

Bulletin No.: 22-NA-153

Subject: Flutter Noise from Right Rear Corner of the Vehicle

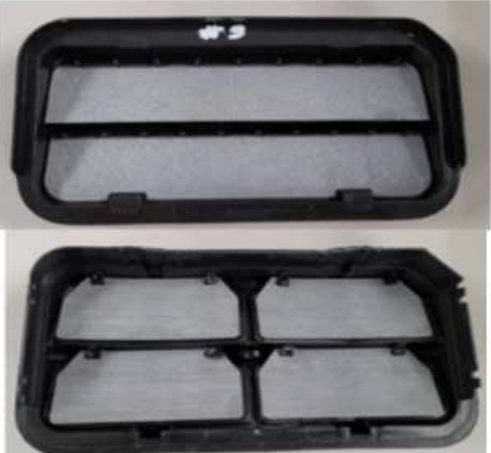
Involved Region or Country	North America, Middle East
Condition	Some customers may comment on a flutter type noise coming from the right rear corner of the vehicle.
Cause	The cause of the condition may be the Pressure Relief Valve (PRV). Note: This condition might be more prone to occur while towing a trailer.
Correction	<div style="text-align: center;">

</div> <p style="text-align: right;">6131341</p> <p>Replace the left and right Pressure Relief Valve with 4 flap design to prevent flapping while pulling trailer.</p>

If you encounter a vehicle with the above concern, replace the pressure relief valve. Refer to *Body Pressure Relief Valve Replacement* in Si.
