Service Bulletin

Bulletin No.: 22-NA-252

Subject: Information on Malfunction Indicator Light (MIL) Illuminated - DTC U0284, U0285, U1345, and/or U2A9 Set

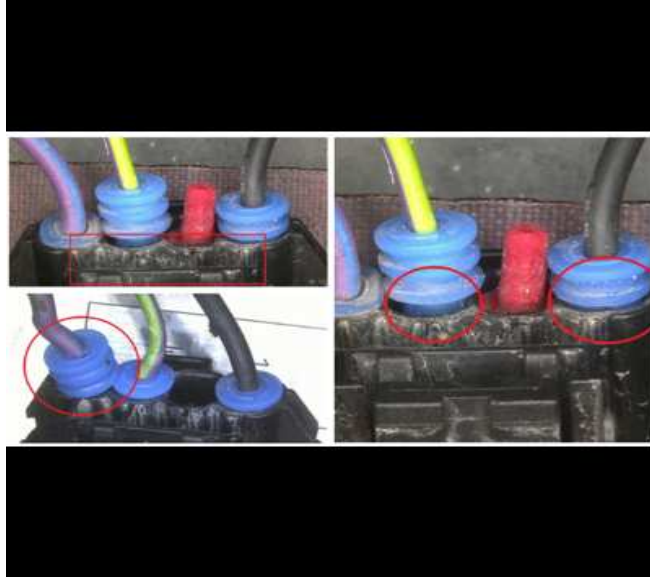
6219342

| Cause 1 | DTC U02A9 and U1345 may be caused by an unsealed pump electrical connector allowing water leakage into the (M10) connector. |

U02A9 might be set with or without U1345. An unsealed pump connector allowing water leakage into the (M10) charge air cooler pump electrical connector might be the root cause of the communication failure.

Check the CAC Pump connector sealing and look for any corrosion at the pump due to water leakage.

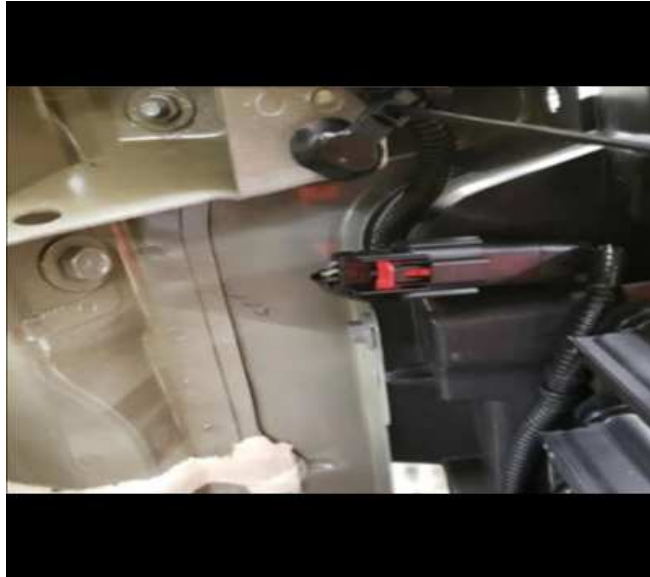
6219339

| Cause 2 | DTC U1345, U0284 and U0285 may be caused by the engine wiring harness to active grille air shutter actuator in-line connector: <ul style="list-style-type: none"> • Not properly connected • Not properly hold by the rear clip • Grounded on the radiator |

Check circuit 4621 connection.

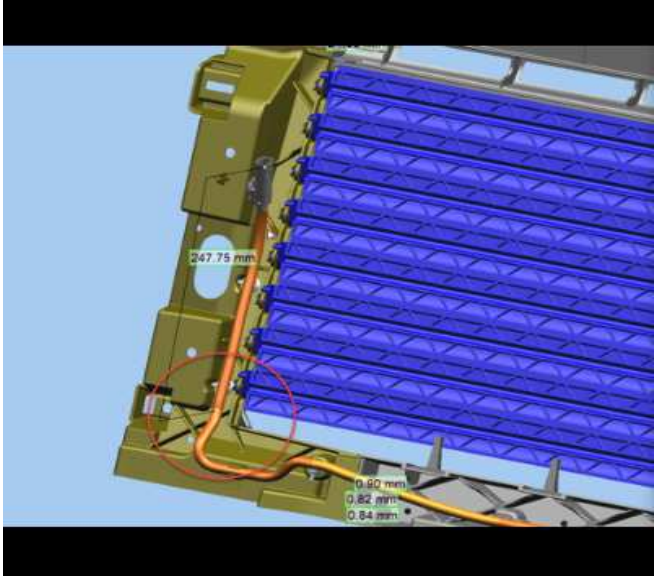
| Cause 3 | DTC U1345 and U0284 may be caused by the active grill air shutter wiring pinched at the radiator support. |

| <p>Correction 3</p> | <p>For DTC U1345 and U0284:</p> <div style="text-align: center;"> </div> <p style="text-align: right; font-size: small;">6219340</p> <p>The graphic above depicts where a pinching condition may be located.</p> <ul style="list-style-type: none"> – Check the active grill air shutter wiring route to identify possible damaged points in the wiring. |
