Service Bulletin

Bulletin No.: 23-NA-086

Subject: Information on Dark Spots Noticed in Headlamp Pattern When Vehicle is Pulled Up to a Wall or Garage

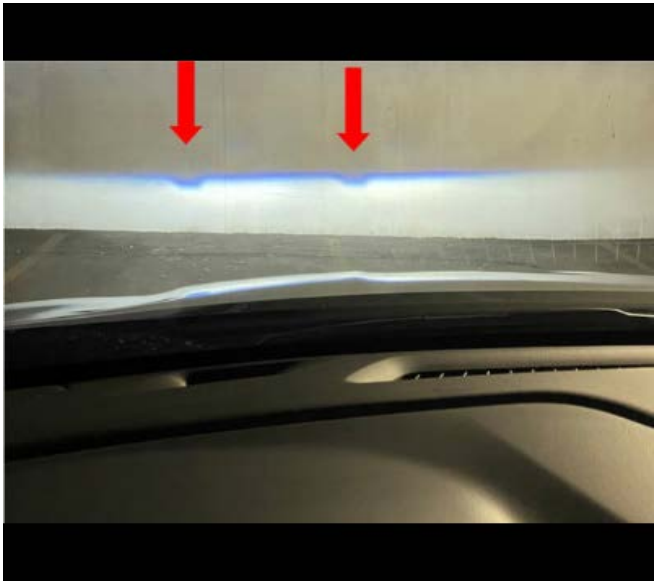
<p style="text-align: right; font-size: small;">6340797</p>
Cause	This dark spot in the lighting pattern in NORMAL and part of compliance with the IIHS safety standards to minimize glare to oncoming traffic.
Correction	DO NOT replace the headlamps for this condition. This is a normal function of the lamps.

Please communicate to the customer that the headlamp system is functioning as designed and this is a normal condition of their vehicle. Please share this information with the customer, including a copy of this message.
