Service Bulletin

Bulletin No.: 23-NA-087

Subject: Information on Possible Water Leaks

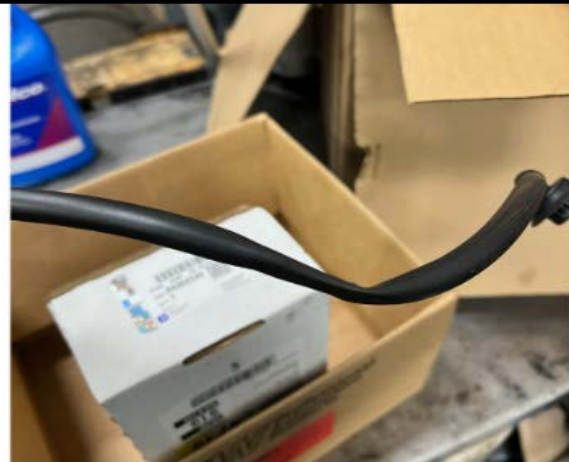
6341782

Drain Hose Kinked Causing Water Leak

| Condition | Some customers may comment on water running down the headliner between "B" and "C" pillars while traveling in the rain. |
| Cause | The cause of this condition may be due to L/R sunroof drain hose is kinked near connection to wheel well. Note: Sometimes may drain normally unless heavy amounts of rain is present. |

| Correction | Replace Left or Right sunroof drain. |

If you encounter a vehicle with the above concern, replace the left or right sunroof drain. Refer to the proper replacement procedure within Si.

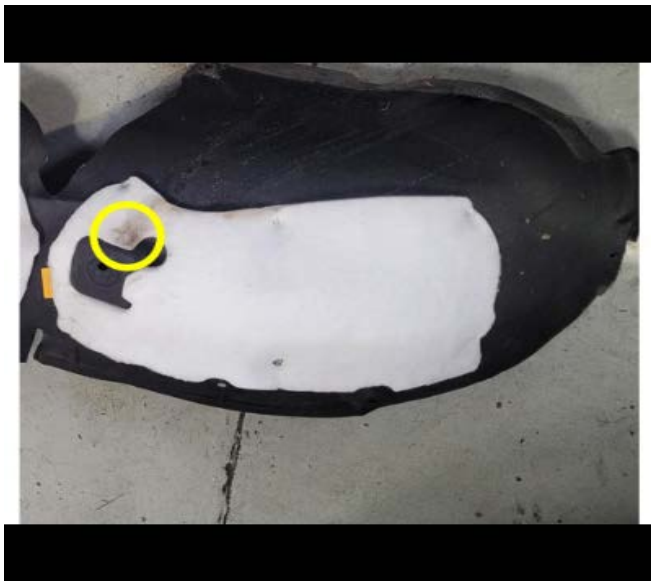
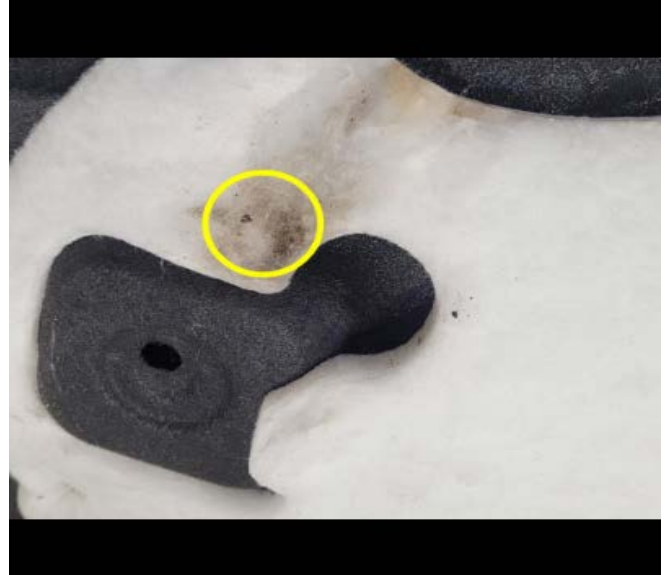
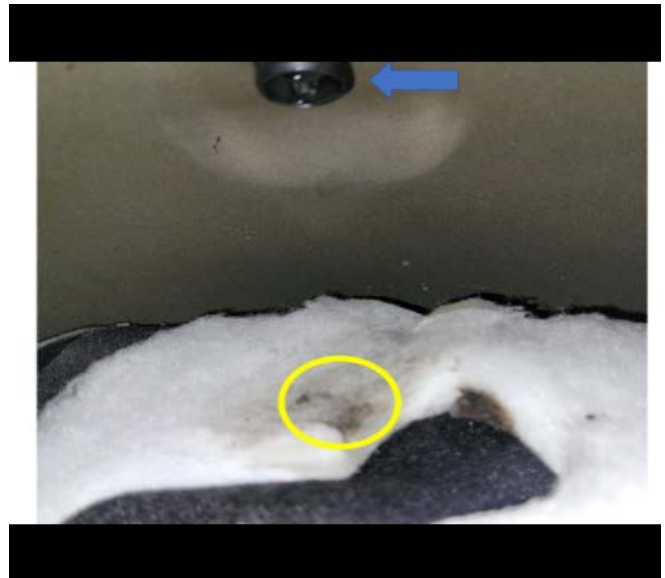
Rear Wheel Well Drain Blocked by Insulation

| Condition | Some customers may comment on a severe water leak into the vehicle. |
| Cause | This condition may be due to the rear drain's being blocked by insulation and not allowing water to flow into the rear wheelhouse liner as intended. |

| Correction | Remove the white insulation in rear liners to allow drains to drain as intended. |

1. Lower the rear wheelhouse liner and visually inspect to see if the white insulation is blocking the end of the drain, as shown above

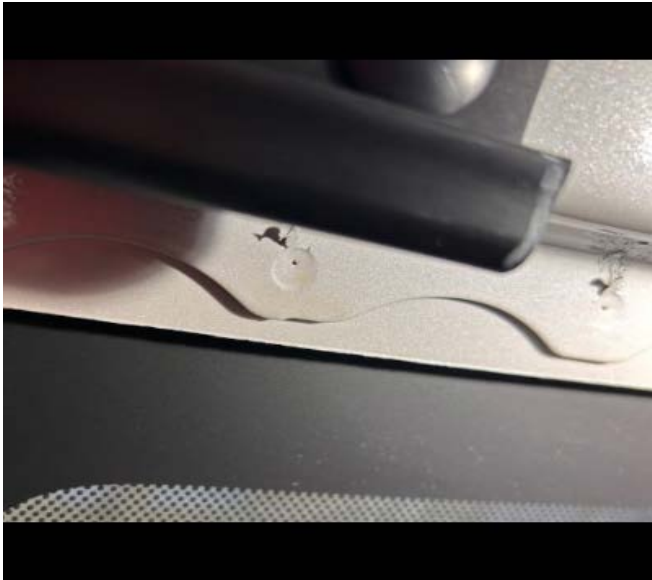
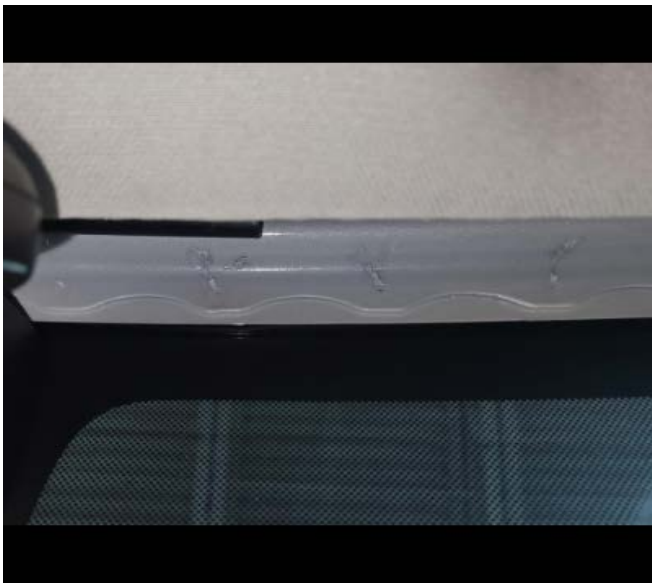
| Condition | Some customers may comment on a water leak originating from the overhead console. |
| Cause | <p>Water test vehicle confirmed leak from overhead console area. Remove overhead console and drop front of headliner. Found leak coming from spot weld at windshield seam. Had windshield removed, found two holes in spot welds on windshield frame. Looks to be burned through on vehicle assembly.</p> <p>This may be due to holes in spot welds on windshield frame and body flange.</p> |

| Correction | Apply seam sealer to holes by following the procedure below. |

1. Drop the front of the headliner, refer to *Headlining Front Trim Panel Replacement* in Si.

2. Visually inspect the windshield frame and body flange for leaks.

3. Once a leak is verified, apply M Ultrapro Autobody Clear Sealant - 08302, or Wurth Euroseal Gel Clear 18920104, or equivalent to locations of leak.
4. Verify condition is corrected and reinstall headliner. Refer to *Headlining Front Trim Panel Replacement* in Si.
