Subject: N222390690 - Service Update  
High Voltage Harness Contacting Metal Edge

Models: 2023 Cadillac LYRIQ

# Service Update

## N222390690 High Voltage Harness Contacting Metal Edge

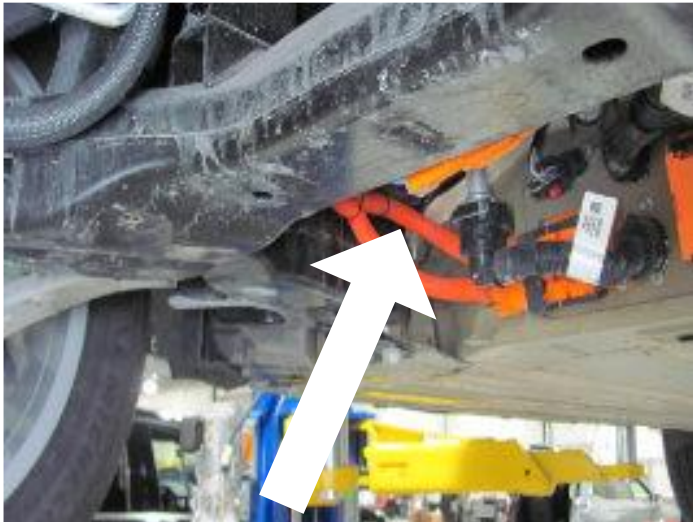
6327068

1. Scan for DTC U2BFF (loss of isolation).
  - If DTC U2BFF is not present, proceed to step two.
  - If DTC U2BFF is present, Disable the high voltage system. Refer to *High Voltage Disabling* in SI. After disabling the high voltage system, if required, proceed to step two.
2. Remove the front compartment insulator. Refer to *Front Compartment Insulator Replacement* in SI.

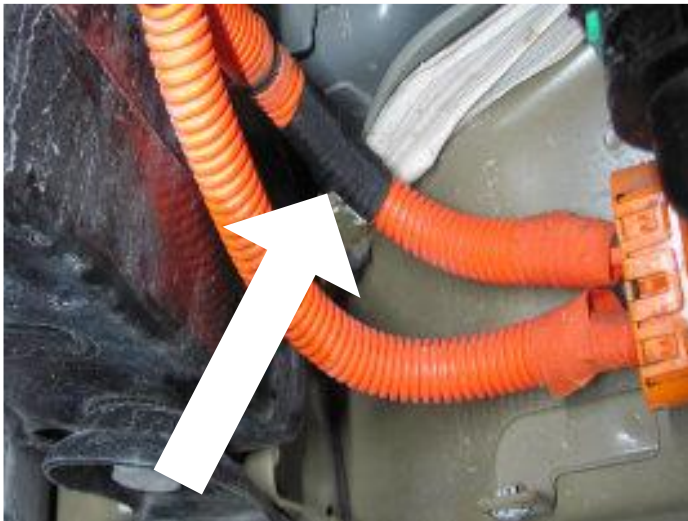
6327072

3. Locate the orange high voltage (HV) cables on the right side of the vehicle in the area where the front subframe bolts to the underbody.

4. Wrap the area of the HV cable adjacent to the stamped metal edge as shown, with 3 layers of a high-quality automotive grade anti-abrasion tape.
