## Clunking or Looseness in the Outer Tie Rod

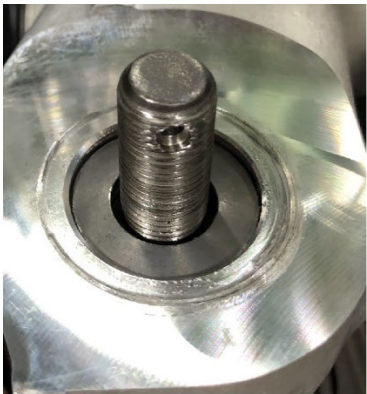
**SAMPLE IMAGE OF GOOD CLEAN SURFACE**

3. Clean the mating surfaces with compressed air before reinstalling. Those surfaces should be smooth and free from any debris.

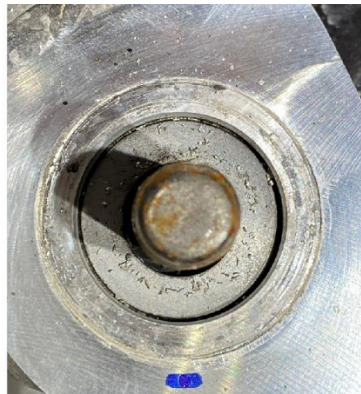
**SAMPLE IMAGE OF SURFACE WITH DEBRIS**
