Service Bulletin

Bulletin No.: 23-NA-091

Subject: Information on Rough Idle, Malfunction Indicator Lamp (MIL) Illuminated After Engine Repairs with DTCs P0016 and/or P0018 Set

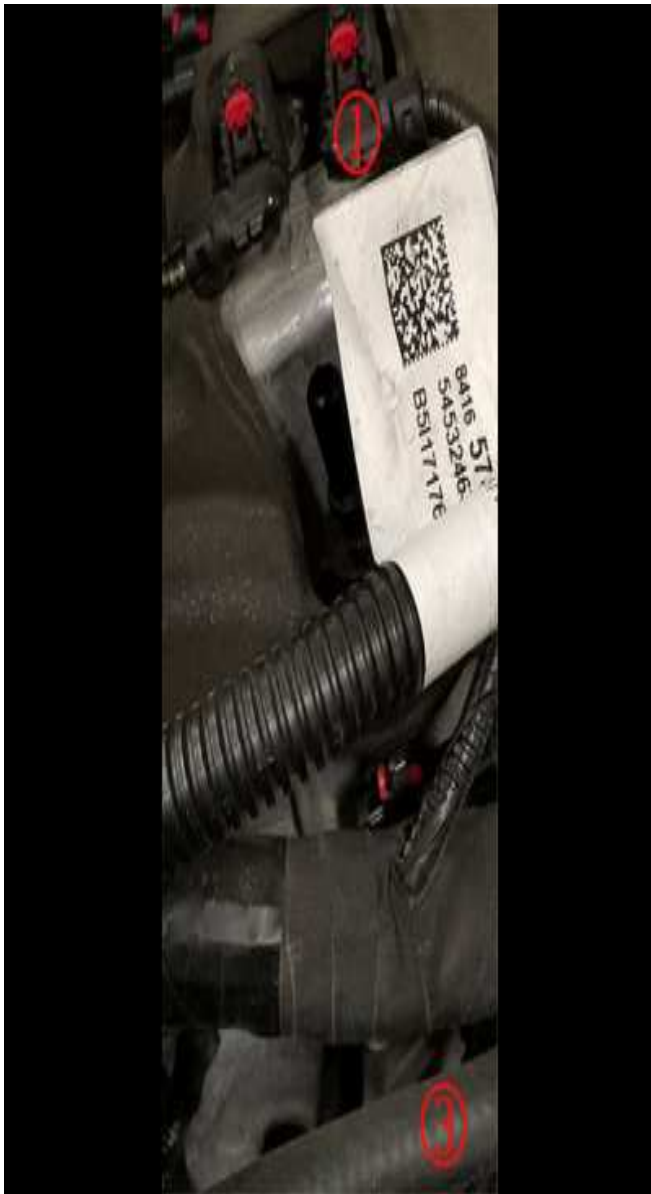
6342807

Involved Region or Country	North America
Condition	Some dealers may find DTC P0016 and/or P0018 set after an engine repair of the engine wiring harness on the right front side of the engine. This will be a hard code and will usually cause a rough idle concern.
Cause	The cause of the condition may be that the wiring connectors for the intake camshaft actuator solenoid bank one on top of the engine, and the connector for the intake actuator park lock solenoid in the front of the engine for bank one have been swapped. These two connectors are identical and can only be identified by wire color in the connector.
Correction	Remove the connector and look at the schematic in Service Information (SI) to compare and ensure the correct connector is plugged into the actuator and lock solenoid.

1. Bank 1 intake actuator
2. Bank 1 intake park lock solenoid
3. Same hose in both pictures shown for location (3)
 - If the connectors are incorrect, swap them back and clear the code to verify the repair.
 - If the connectors are already in the correct position, then refer to the correct service information diagnostics for this DTC.
