| ELE | 2020MY<br>Telluride (ON) LX/S/EX<br>w/Halogen Headlamp |
| 296 | May 2023 |

## TECHNICAL SERVICE BULLETIN

### HALOGEN HEADLAMP REPLACEMENT

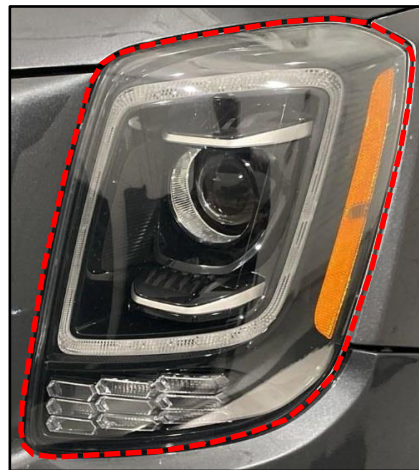
Halogen Headlamp Assembly

This bulletin provides information associated with the 'Halogen Headlamp High Beam Warranty Extension Program' (WTY030) to replace the affected (left and/or right side) headlamp assembly on certain 2020MY Telluride (ON) LX/S/EX vehicles, produced at Kia Georgia from January 09, 2019 through November 18, 2019, which may exhibit a loss of high-beam functionality. Due to an internal failure in the headlamp, the high-beam lights may not illuminate when turning the light switch from the low to high beams. The low-beam function is not affected. The vehicle's warranty for this issue will be extended from 5 years/60,000 miles to 15 years/150,000 miles, whichever comes first, starting from the date the vehicle was first put into service. Follow the procedure outlined in this publication to replace the (left and/or right side) halogen headlamp assembly with a new part.

1. Replace the affected (left and/or right side) 'halogen' headlamp assembly by referring to "Body Electrical System → Lighting System → Headlamp → Repair procedures" in the applicable Shop Manual on KGIS.

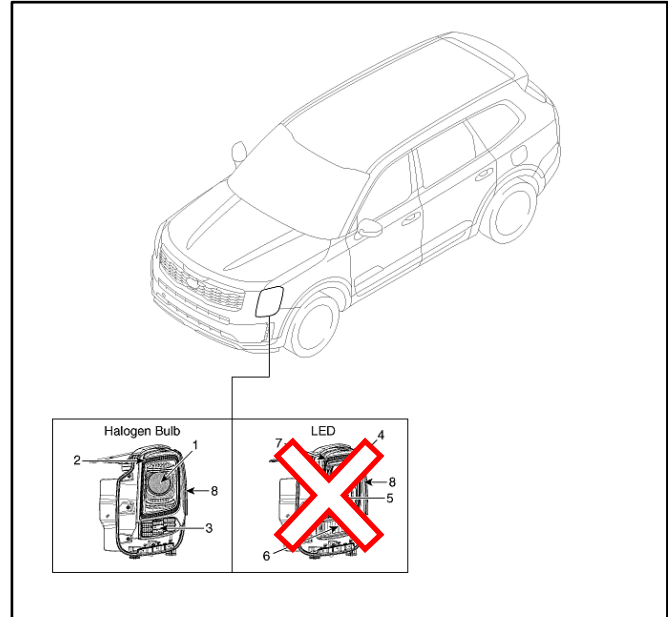
1. Low/High Beam
2. Daytime Running Light
3. Turn Signal Lamp
8. Side Marker

2. Perform Head Lamp Aiming (Adjustment) "Body Electrical System → Lighting System → Headlamp → Repair procedures" in the applicable Shop Manual on KGIS.
3. Confirm normal headlamp lighting function and low-beam/high-beam operation.
