### PIT5887C Diagnostic Aid: Intermittent Vehicle Powers Up But Will Not Crank

Involved Region or Country:	North America
Condition:	Intermittent No Crank. Vehicle Powers Up Normally.
Cause:	Oxidized B+ Nut or Stud On The Starter Solenoid.

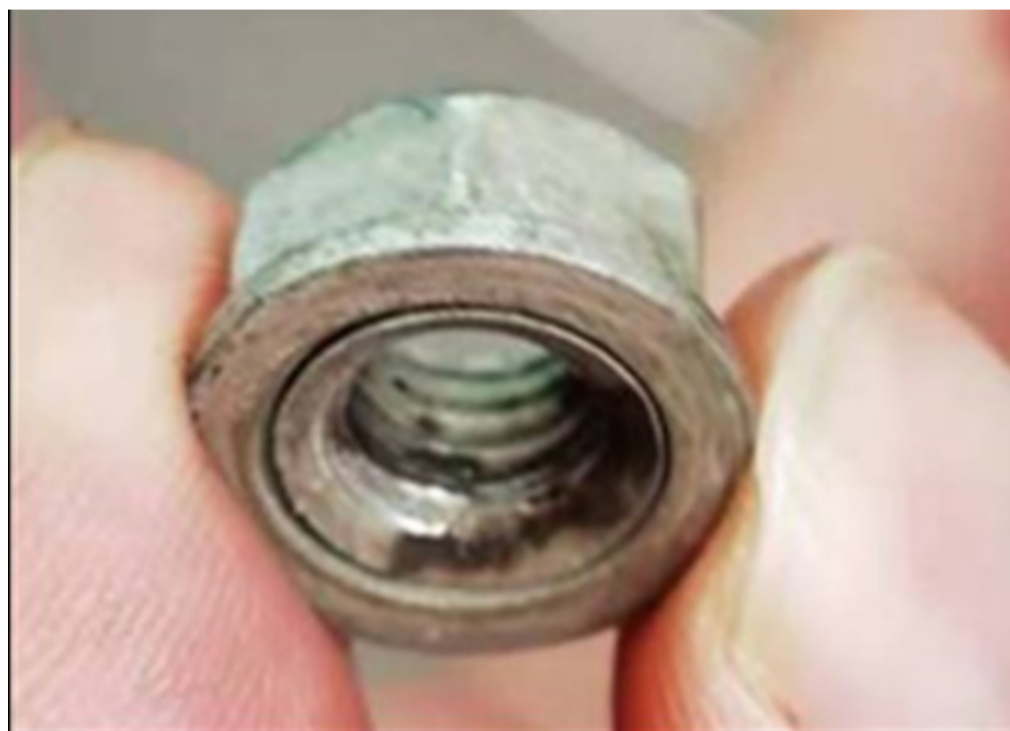
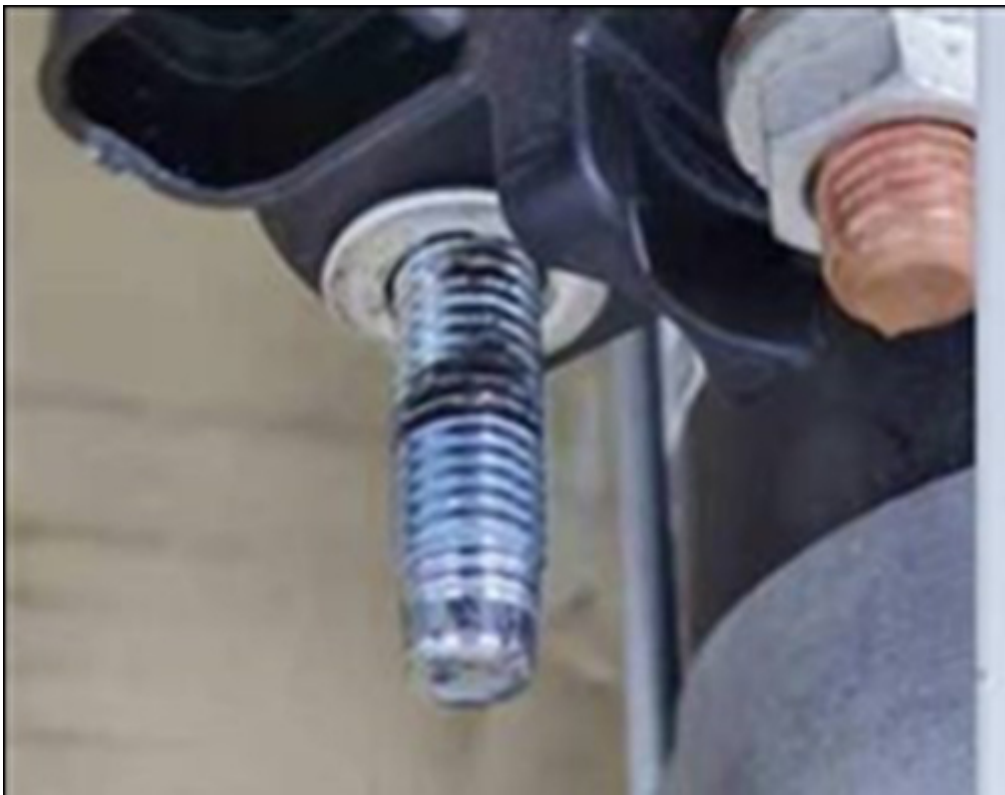
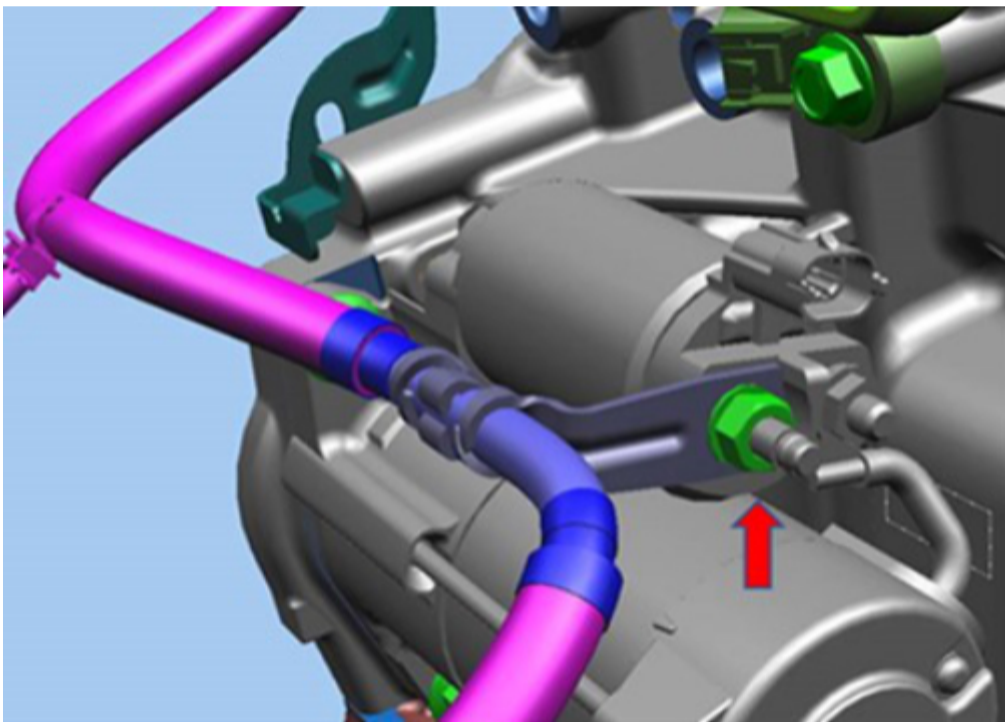
If present, inspect the B+ stud on the starter for oxidation as shown below.

If it's oxidized as shown in the photos, you should replace the nut and clean the stud terminals and re-check starter function.
