### PIC6495A Volt battery Section Replacement – missing retainers

#### Models

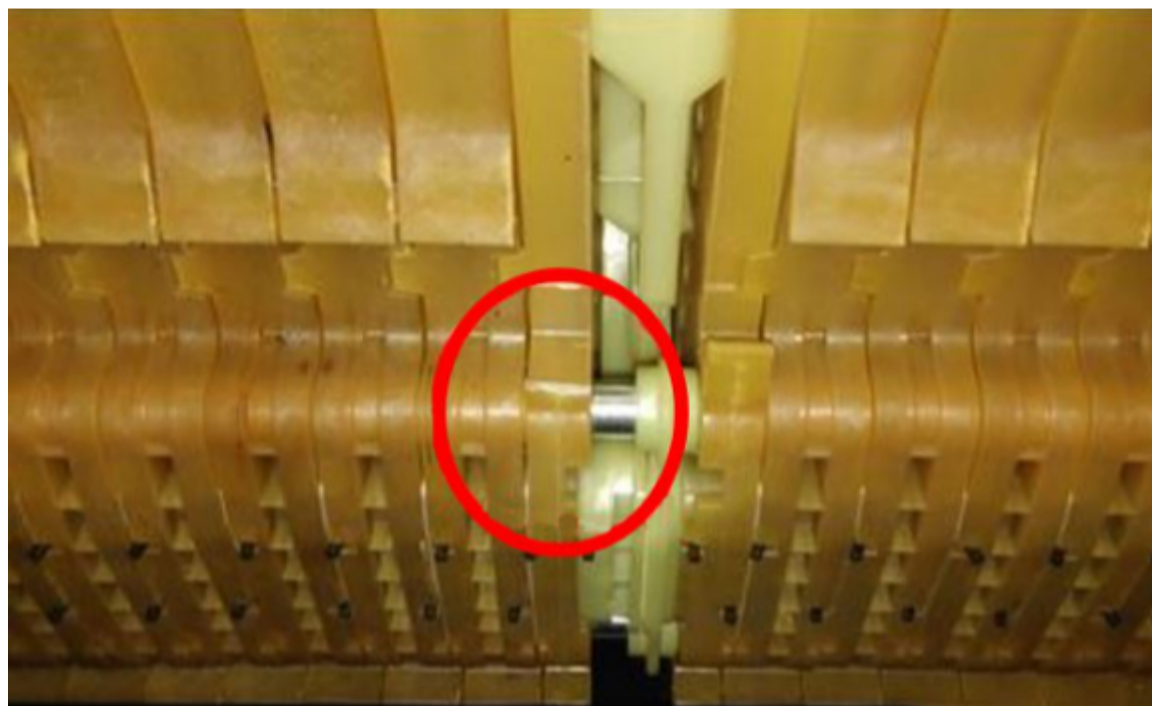
Involved Region or Country	North America
Condition	Dealers replacing a HV battery section for any reason may encounter a replacement section that is missing one or more “tabs” for retaining the wiring harness.
Cause	Due to variances in manufacturing some sections were built missing some retaining tabs, there is no reliability concern from this condition.

Missing Tab: Shown in the red circle

The missing tabs do not impact performance or reliability of the part, the wiring harness routing should be performed using the steps below.
