Preliminary Information

PIT5970A Zoomed In - Pointed Downward Rear-View Camera

Proactive

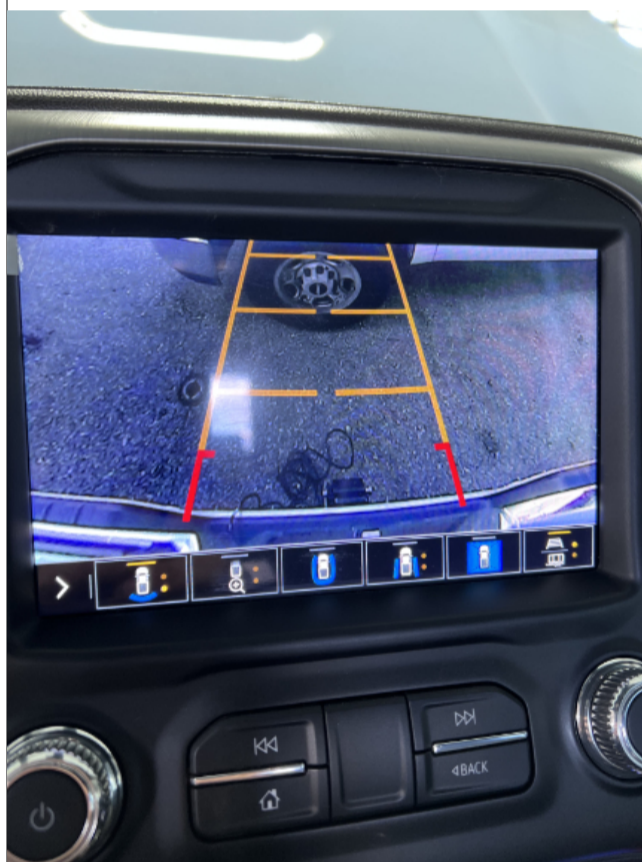
Condition Some customers may comment that their camera view appears to be pointing downwards or have a zoomed in appearance.

Cause When the customer travels long distances with a heavy object attached to trailing attachment point on vehicle (i.e Heavy Trailers, Boats, any vehicle accessories etc) will create this phenomenon.

1. Verify the "Zoomed In — Pointed Downward Rear-View Camera" condition is visible on display, please follow the next steps.
2. Confirm that there is no physical damage associated to rear camera/rear tailgate area.
3. Remove any trailers/accessories from vehicle.
4. Once vehicle is at a free-state without any trailering attachments, technician shall drive vehicle under 10 MPH in a straight line until VPM rear camera re-alignment.
5. VPM will re-align rear camera respectively. Perform 2 Key Cycles and place vehicle in reverse to confirm camera viewport is in nominal condition.
