# Preliminary Information

## PIT5970B Zoomed In - Pointed Downward Rear-View Camera

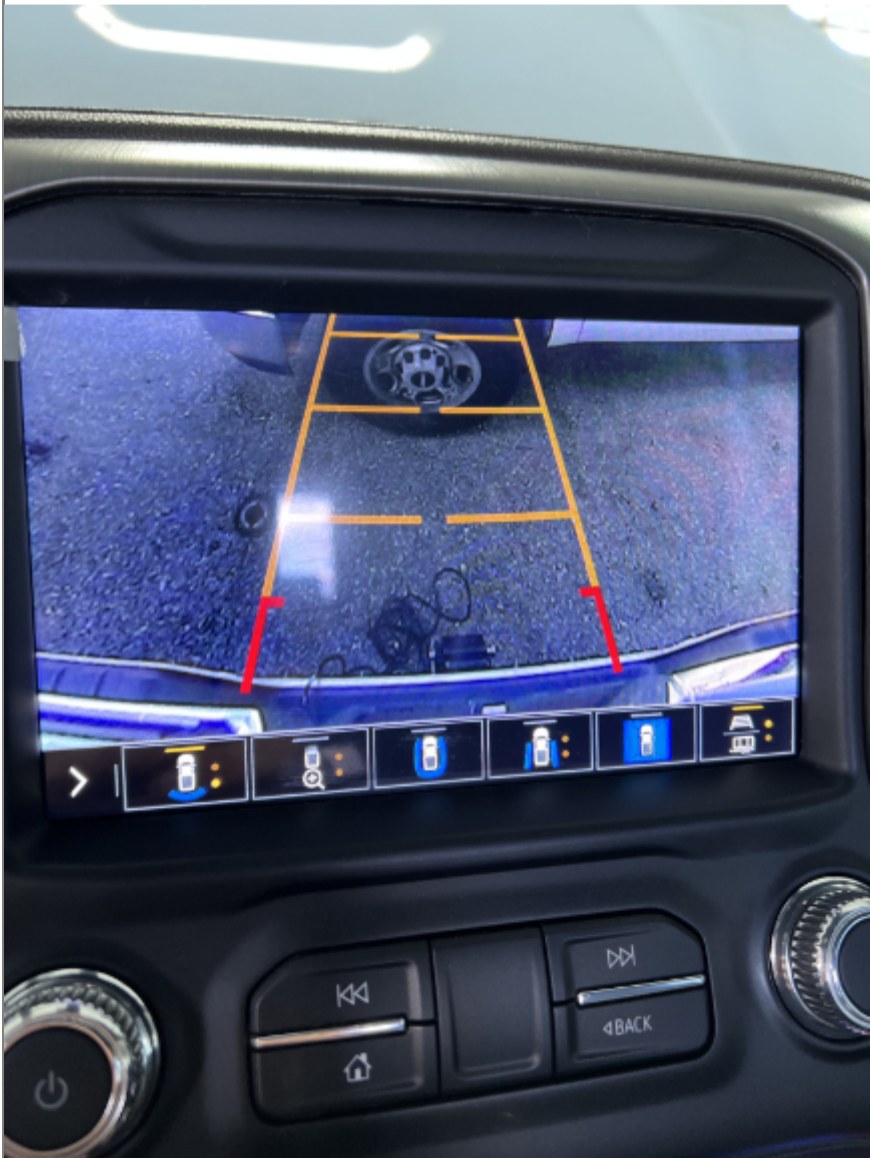
Condition: Some customers may comment that their camera view appears to be pointing downwards or have a zoomed in appearance.

Cause	When the customer travels long distances with a heavy object attached to traling attachment point on vehicle (i.e Heavy Trailers, Boats, any vehicle accessories etc) will create this phenomenon.
-------	--

1. Verify the “Zoomed In — Pointed Downward Rear-View Camera” condition is visible on display, please follow the next steps.
2. Confirm that there is no physical damage associated to rear camera/rear tailgate area.
3. Remove any trailers/accessories from vehicle.
4. Once vehicle is at a free-state without any traling attachments, technician shall drive vehicle under 10 MPH in a straight line until VPM rear camera re-alignment.
5. VPM will re-align rear camera respectively. Perform 2 Key Cycles and place vehicle in reverse to confirm camera viewport is in nominal condition.
