Preliminary Information

PIT6005 Loss Of Applications On Right Side Of Radio Screen

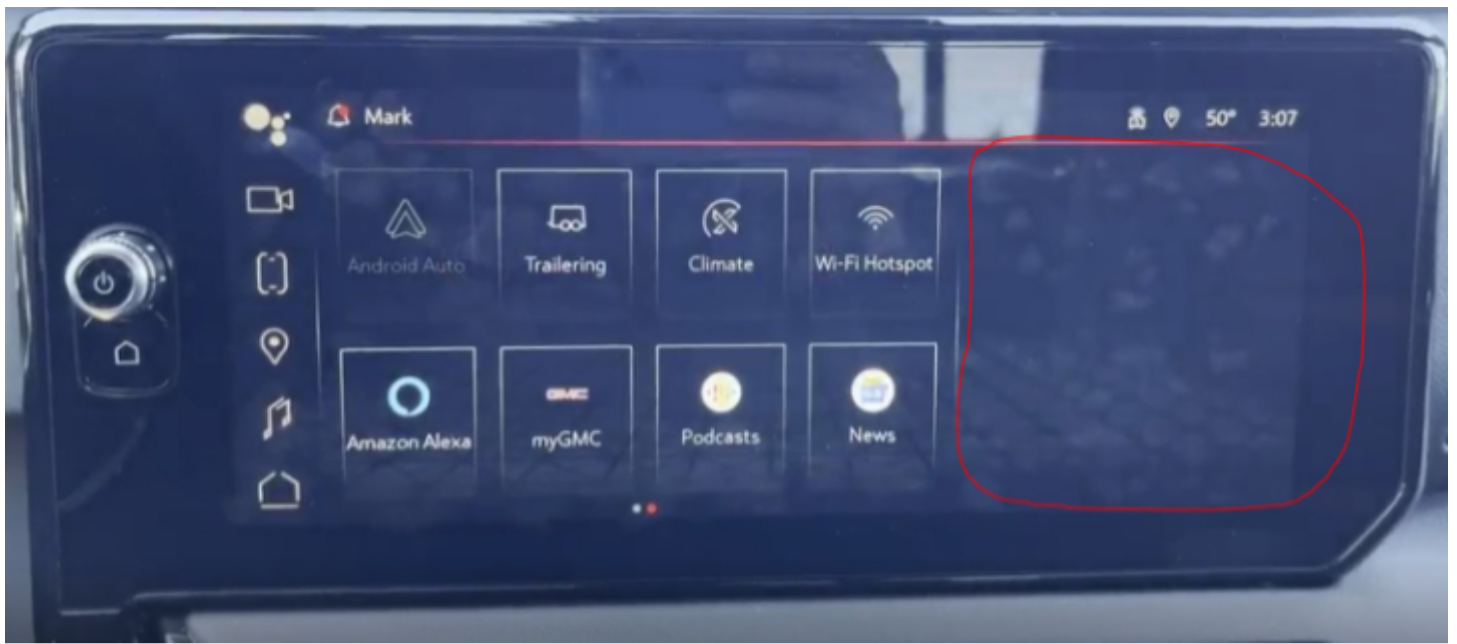
Involved Region or Country	North America
Additional Options (RPO)	IOK
Condition	Some customers may comment that the right side of the center stack display is not showing applications. This is sometimes referred to as Porch View, or Card View.
Cause	This may be caused by a software anomaly.

Inspect the radio and confirm that the section shown in the picture below is not able to show applications, such as Maps or Clock.

This appears to be caused by an issue with the customer's Profile. Create a new Profile and confirm that the applications show normally.

If the new Profile fixes the concern, delete that Profile and the one that that customer was using.

If the new Profile does not fix the concern, perform a data reset on the system and then try to create a new profile again to make sure it works.

Settings\System\Reset Options\Erase Infotainment Data
