PIT5993A No Crank Due To Dead Battery / Battery Draw / Unwanted Alarm

Brand:	Model:	Model Years:	VIN:		Engine:	Transmissions:
			from	to		
Cadillac	Escalade Models	2021 - 2023	All	All	All	All
Chevrolet	Suburban	2021 - 2023	All	All	All	All
Chevrolet	Tahoe	2021 - 2023	All	All	All	All
GMC	Yukon Models	2021 - 2023	All	All	All	All

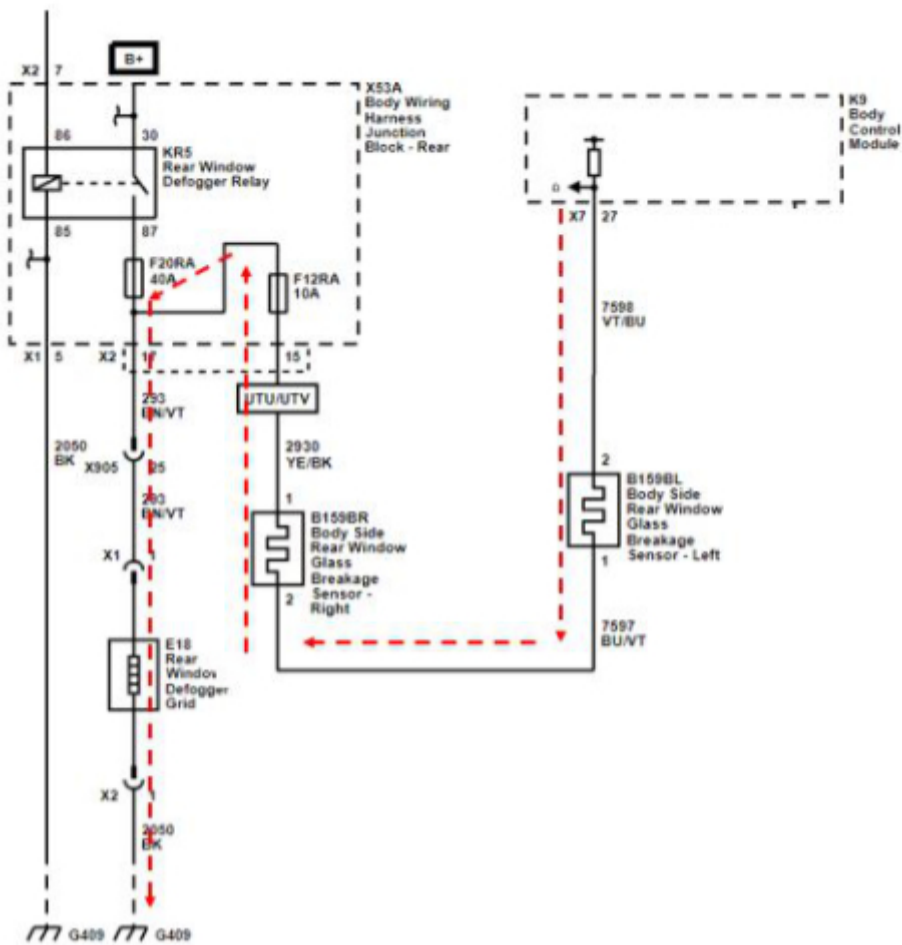
Involved Region or Country	North America
Additional Options (RPO)	Theft-deterrent alarm system RPO UTT Or UTR
Condition	Some customers may comment on a low or dead battery, no crank due to a dead battery or unwanted alarm.
Cause	<p>These concerns could be caused by high resistance in the glass breakage loop, which is shown below with a dotted red line. The glass breakage loop consists of the rear window defogger grid and each rear quarter glass, which are all connected in series. Normally, the complete glass breakage loop should have less than 20 ohms of resistance to ground. If there is high resistance or a break at any place in this series circuit, it could cause the condition.</p> <p>Note: In some cases, the battery draw can only be duplicated if the vehicle is completely closed up (all doors and hood latches tripped) and the vehicle is locked, but in other cases the vehicle does not need to be closed and locked up.</p>

If the resistance to ground is greater than 20 ohms, then inspect the glass breakage loop for poor connections, which could occur at any point in the series circuit, shown above. The most common areas seen are the connections at either of the rear quarter glass assemblies.

To test the glass breakage loop, disconnect the battery and the BCM X4 and X7 connectors. Using the correct test probe (EL-38125-58) check for proper terminal tension at the BCM X7 terminal 27. If terminal tension is good then use an ohmmeter to check the resistance of the glass breakage loop to the BCM ground. Do this by connecting one lead of the ohmmeter to the BCM ground at connector X4 terminal 24 or 25 and the other ohmmeter lead to terminal 27 of the BCM X7 connector. Measure the resistance.

If the resistance to ground is less than 20 ohms, then the loop resistance is within spec, but if you are dealing with an intermittent issue then inspect and manipulate the glass breakage loop connections/wiring to see if the resistance increases. Repair any points of high resistance.
