FROM: Maserati TSO

# Rapid Update 609 Grecale MY23 - Electrical steering wheel column control stuck (OPT 137)

DATE: APRIL 19, 2023

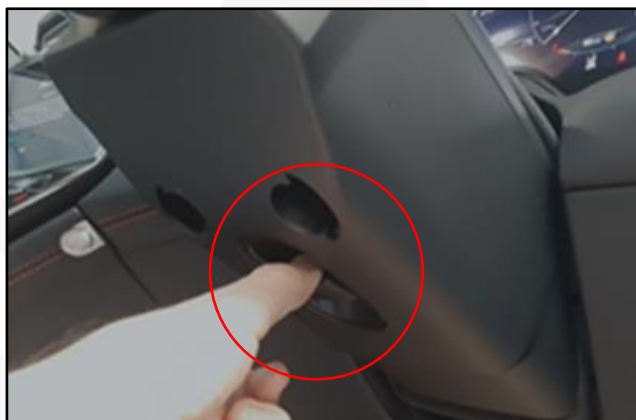
1. Always check ModisCS+ to see if the vehicle is involved in this action and if it has not been previously performed.
2. Switch the Ignition to the "ON" position.
3. Use the "power tilt/telescoping steering column/wheel switch" to operate the power tilt/telescopic steering column in the following sequence below:

- a. 3 UP activations
- b. 3 DOWN activations
- c. 3 SLIDE FORWARD activations
- d. 3 SLIDE BACK activations

For each activation and each position, please check the following conditions:

- An acoustic "click" must be audible.
  - At the end of the action, the button must return to the base or resting position.
  - The steering wheel movement must stop when releasing the button.
4. Switch the Ignition "OFF".
  5. If all the conditions are satisfied for all the activations, the **check is OK**, no further operation is needed, the procedure is complete.
  6. If at least one of the conditions is not verified for one or more activations, the **check is NOT OK** and the component must be replaced, following the procedure below (available in the workshop manual):
    - **8.50.055.0 - STEERING COLUMN ADJUSTMENT CONTROL - Removal/refitting or replacement**
  7. Operation complete.

Replace **ONLY** if the inspection did not pass (**NOT OK**):

| Spare parts | PN | QTY |
|---|---|---|
| STEERING COLUMN ADJUSTMENT CONTROL | 670265777 | 1 |
