Lack of Maintenance Reminder in MID

Service Category Vehicle Interior

Section Meter/Gauge/Display

YEAR(S)	MODEL(S)	ADDITIONAL INFORMATION
2023	bZ4X

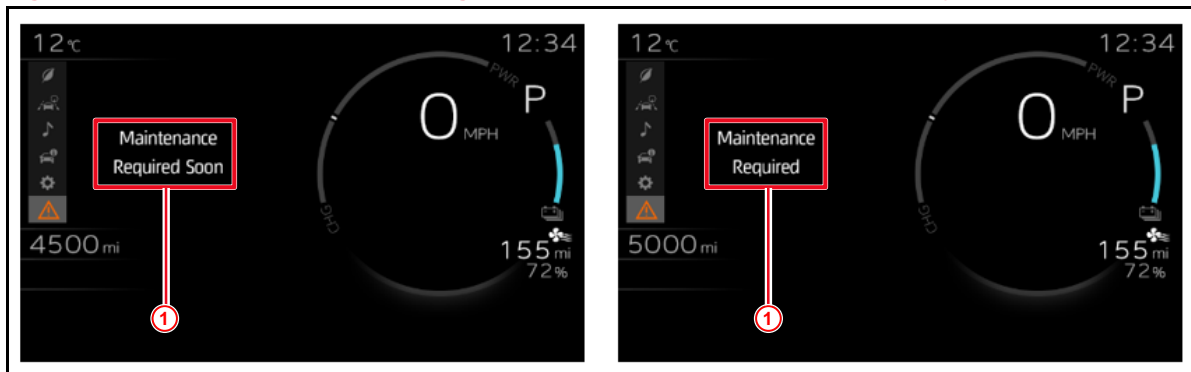
Figure 1. Maintenance Reminder Messages on MID in Combination Meter Assembly

Some 2023 model year bZ4X vehicles may exhibit a condition in which the maintenance reminder messages (Figure 1) do not display on the multi-information display (MID) in the combination meter at scheduled maintenance intervals. The combination meter ECU has been updated to address this condition. Follow the Repair Procedure in this bulletin to reprogram the combination meter ECU.

NOTE
When the condition occurs, maintenance messages do not display on the combination meter.

Follow the procedures outlined in [T-SB-0134-16](#), *Techstream ECU Flash Reprogramming Procedure*, and [T-SB-0107-20](#), *ECU Flash Reprogramming With Security Signature*, and flash the combination meter ECU with the NEW calibration file update.
