SIB 35 01 23

CREAKING NOISE FROM THE BRAKE PEDAL AREA

G70 (7 Series Sedan)	G70 i7 xDrive60 Sedan (BEV)	i20 (iX Sports Activity Vehicle)
----------------------	-----------------------------	----------------------------------

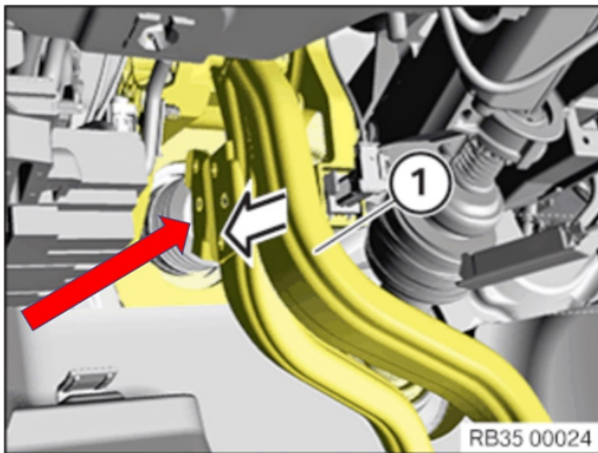
When the brake pedal is pressed/ released, a creaking noise may be heard from the pedal area for the Integrated Brake System (IB).

Unfavorable tolerance in the connection between the pedal mechanism and the IB.

Adjustment of the IB piston rod in the area indicated by the red arrow
