SIB 51 05 23 SERVICE ACTION: REAR WINDSHIELD

2023-04-20

E-Series	Model Description	Production Date
G42	2 Series Coupe	February 8, 2023 – February 10, 2023
G87	M2 Coupe

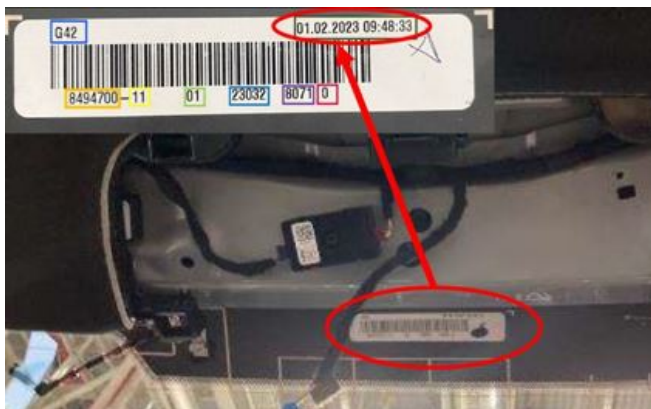
The bracket that holds the center high-mounted stop lamp (aka third brake light) may loosen over time, causing a rattling sound in the rear of the vehicle.

The third brake light bracket may not have been properly glued. Estimated failure rate is 45%.

Check the production date on the rear windshield and replace if necessary.

1. Remove the third brake lamp following the repair instructions listed in AIR/ISTA (63 25 003).
2. Check the production date on the rear windshield:
 - If the windshield has a production date of 01/02/2023 (Feb. 1, 2023) as shown above, the rear windshield requires replacement. Follow the repair instructions listed in AIR/ISTA (51 31 200).
 - If the rear windshield has a different production date, no repair is needed, and the vehicle can be reassembled
