SIB 52 06 23

## DELIVERY STOP: FRONT REAR SEAT CROSSMEMBER

This Service Information Bulletin (Revision 1) replaces SI B52 06 23 **dated March 2023**.

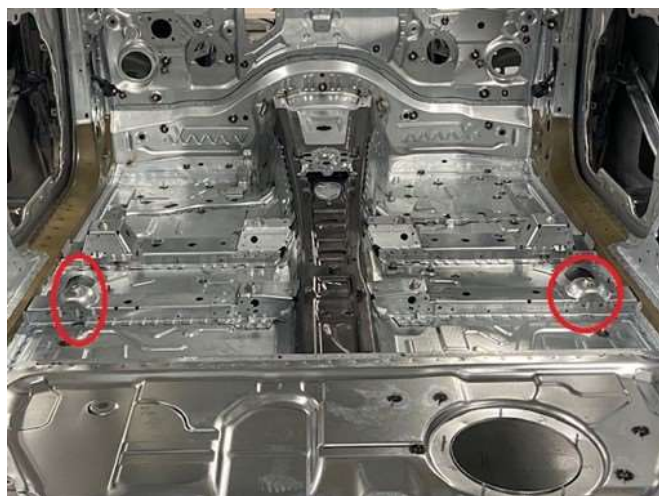
looking frontwards) can form.

It was discovered that an indentation or crack on the driver and/or passenger seat crossmember rear outer dome (circled; viewed

A metal stamping error during production, on a small amount of the affected vehicles.

Inspect the driver's seat left rear (L/R) mounting dome as well as the front passenger's seat right rear (R/R) mounting dome for evidence of a metal crack or indentation as shown in the photos.

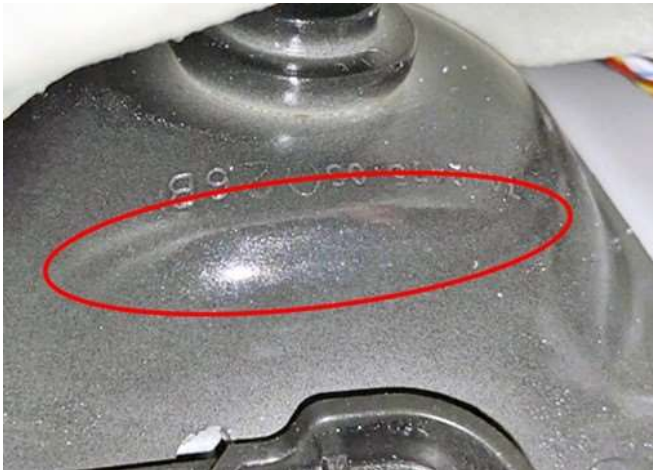
Not OK: Indent.

Go to Step 2.

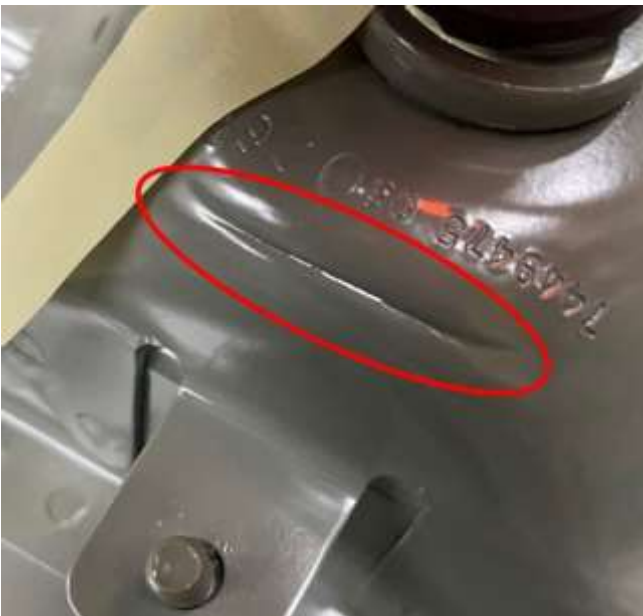
Not OK: Cracked/torn

Go to Step 2.

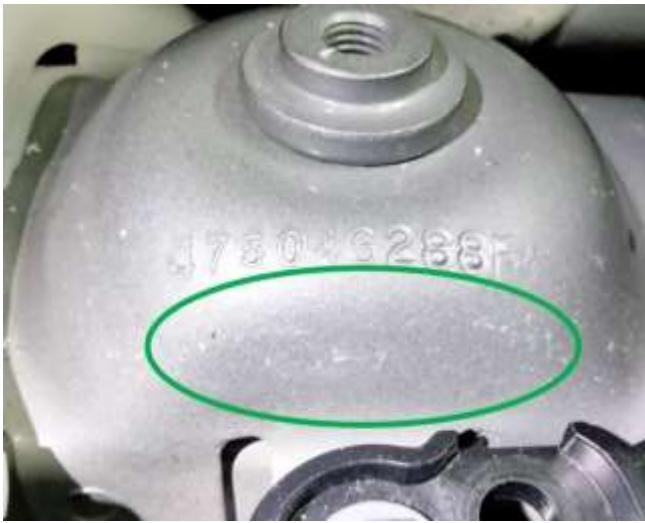
A "good" dome does not show any indications of an indent, nor of a crack/tear.

If both rear outer domes resemble this photo, go to Step 9.
