SIB 63 05 23

DAYTIME RUNNING LIGHT IS DIM OR DISCOLORED

E-Series	Model Description
G70	7 Series Sedan

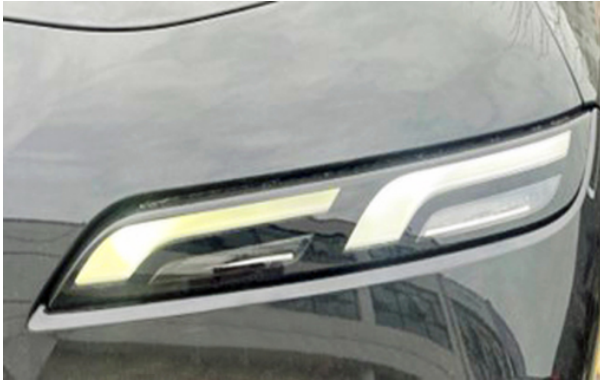
One or more of the LED daytime running lights are dim or discolored, such as this example in which the inner light is “yellowed”.

The connection between the LED module and the light tube inside the headlamp housing is damaged.

Inspect and replace the affected LED module and the headlamp housing.

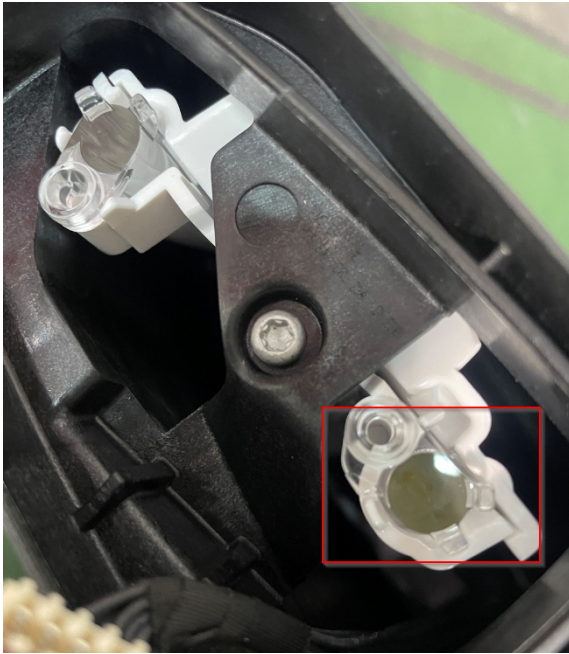
2. Inspect the headlamp and LED module for signs of discoloration as shown in the photo.

**Note: If discoloration is seen, the affected headlamp and LED module require replacement.**
