SIB 64 04 23

2023-04-14

NOISE FROM THE FRONT LEFT OF ENGINE COMPARTMENT

E-Series	Model Description	Production Date
G70	i7 xDrive60 BEV (Battery Electric Vehicle / All-Wheel Drive)	Vehicles produced up to March 31, 2023

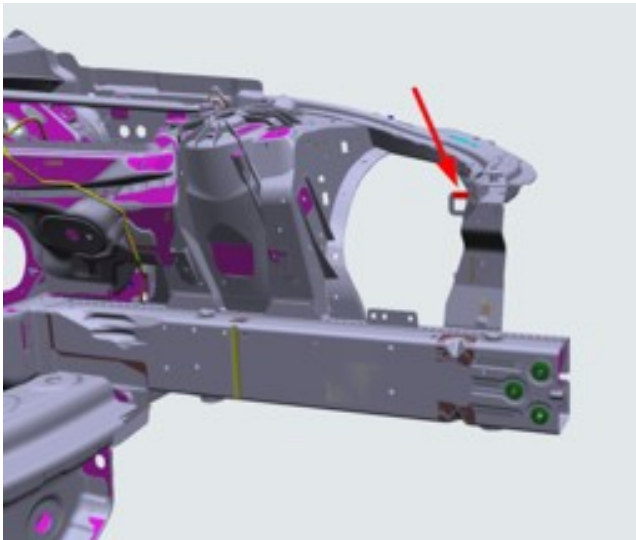
The body support bracket is located here on the vehicle frame in the left front of the engine compartment.
