## 2021 Ontour

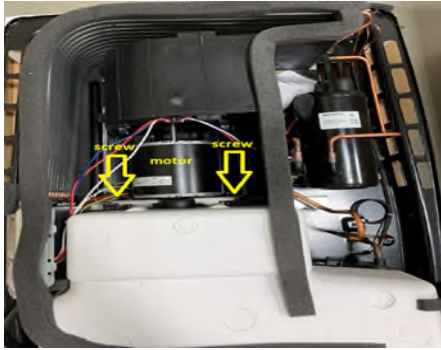
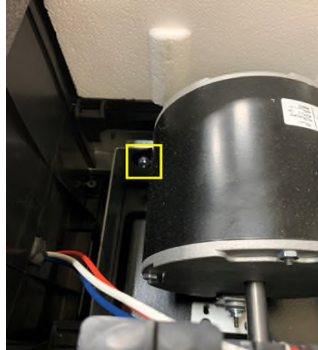
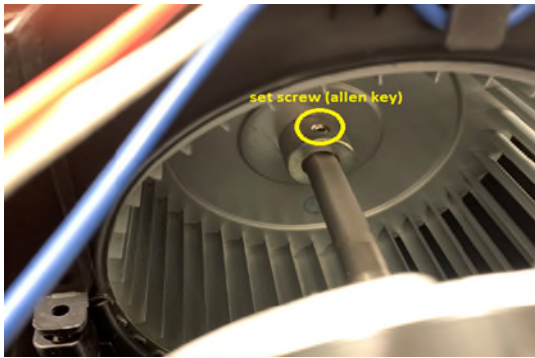
If black plastic is coming out of the AC vent, that typically means the fan blade has shifted and is contacting the plastic housing. To repair, access the roof and remove the cover, there should be 4 shoulder type screws securing it at the base. Then look at the motor and on each side is a bolt securing it in place. There is also a set screw on the fan shaft that needs to be tightened down. if any threads are sticking up on the set screw, that typically means it is loose.
