Subject: N232397070 - Service Update

End Gate Cable

Models: 2023 GMC Sierra 1500

N232397070 Endgate Cable Incorrect Build

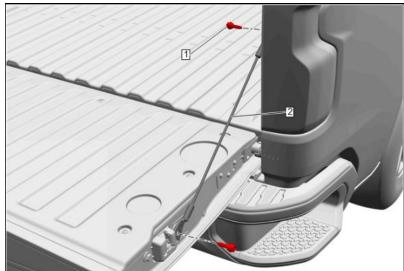
5028829

Condition	Certain 2023 model year GMC Sierra 1500 vehicles may have a condition in which the vehicle has the	
	incorrect endgate cable installed.	
Correction	Dealers are to replace the endgate cable.

1. Replace both the left and right Endgate Cables (2). Refer to Endgate Cable Replacement in SI.
