Service Bulletin

Bulletin No.: 23-NA-084

Subject: Blue Hourglass and No Gridlines While in Reverse

Brand:	Model:	Model Year:		VIN:		Engine:	Transmission:
		from	to	from	to		
Cadillac	Escalade	2021	2023

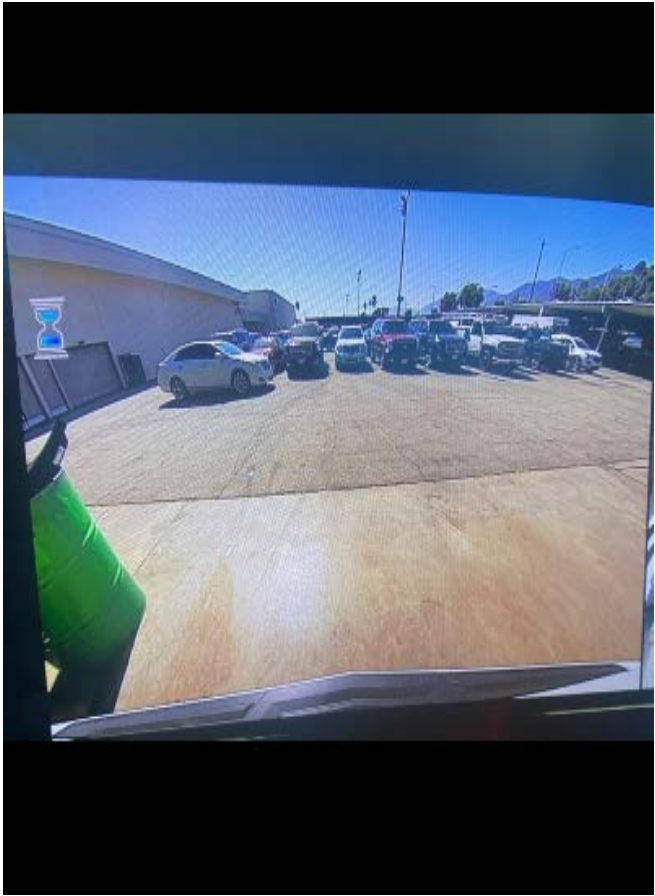
<p style="text-align: right; font-size: small;">6342841</p> <p>Some customers may comment that when attempting to reverse, the rear-view camera on the radio display will have a blue hourglass in the upper left-hand corner and no gridlines in view.</p>
------------------	---

Cause	The cause of the condition may be software anomalies in the Video Processing Module (VPM).
Correction	Reprogram the VPM with the latest software. Important: The vehicle must be driven for 5 minutes between 3-5 mph (5–8 km/h) to ensure gridlines have reappeared.

1. Reprogram the Video Processing Module. Refer to *K157 Video Processing Control Module: Programming and Setup in SI*.
