Service Bulletin

Bulletin No.: 23-NA-090

Subject: Water Intrusion at Front Door Harness Connector X500 and/or X600

Brand:	Model:	Model Year:		VIN:		Engine:	Transmission:
		from	to	from	to		
Buick	Enclave	2021	2023				
Chevrolet	Traverse

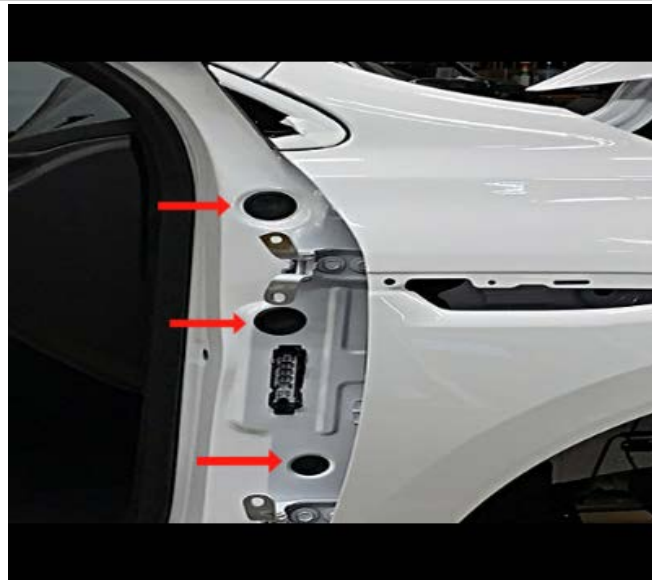
6054534

- A-Pillar body plugs are missing

<p style="text-align: right;">6054545</p> <ul style="list-style-type: none"> • Door harness grommet are not fully seated
<p>Correction</p>	<p>DO NOT repair the connector or replace the harness without addressing the water source. Once the source of the water intrusion is corrected, then repair connector as required. Refer to SI for proper wire repair procedure.</p>

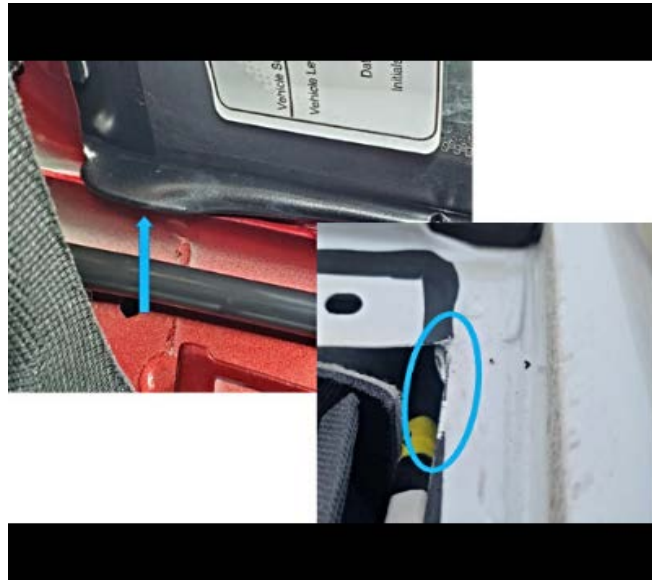
6054536

- Windshield urethane is off it's location
