Subject: N222382520 - Service Update
Intermediate Steering Shaft Bolt

Models: 2023 Cadillac LYRIQ

Service Update

N222382520 Intermediate Steering Shaft Bolt

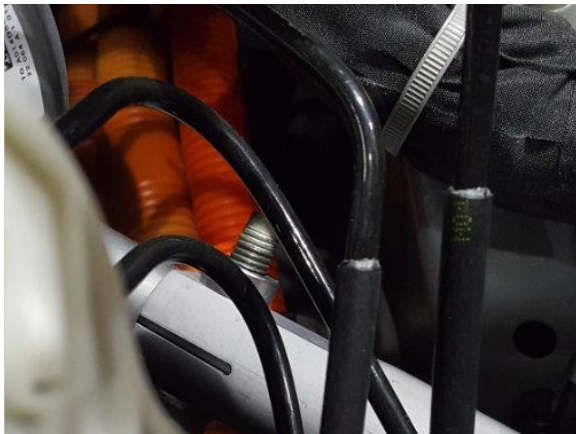
6196305

2. Rotate the steering wheel so that the intermediate shaft bolt has the threaded end pointing towards the wire harness secured to the strut tower, as shown.

3. Using feeler gauges, calipers, or another convenient measuring tool, check to ensure the distance between the intermediate shaft bolt and the body wiring harness is **at least** ¼ inch (7 mm).

- If the distance between the intermediate shaft bolt and the body harness is at least ¼ inch (7 mm) proceed to step 5.
 - If the distance between the intermediate shaft bolt and the body harness is **not** at least ¼ inch (7 mm), replace the bolt with the part number provided in the parts list for this field action, torquing to 43 lb ft (58 N-m) then proceed to step 4.

- If there is any damage from the intermediate shaft bolt rubbing the body harness, repair the damage at this time. Refer to *Wire-to-Wire Repair* in SI.

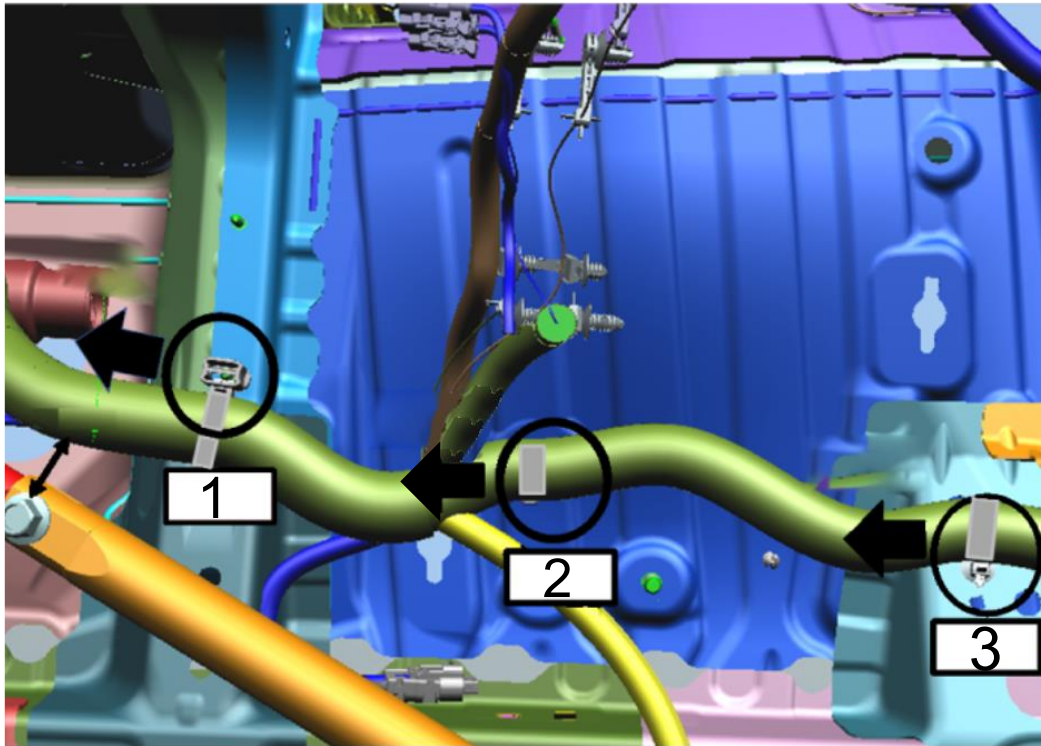
6196309

4. With the intermediate shaft bolt still oriented so the threaded end faces the body harness, recheck the clearance in the same fashion as step 3.
 - If the distance between the intermediate shaft bolt and the body harness is at least ¼ inch (7 mm) proceed to step 5.

- If the distance between the intermediate shaft bolt and the body harness is **not** at least ¼ inch (7 mm), remove the clips from the body wiring harness at locations 1, 2, and 3, and shift the wire harness towards the front of the vehicle (move the clips rearward on the harness) 1.25 inches (30mm) before re-attaching the clips to the harness.
