Technical Service Bulletin

94 Exterior lights have moisture accumulation

94 23 64 2012749/16 May 9, 2023. Supersedes Technical Service Bulletin Group 94 number 21-34 dated February 17, 2021, for reasons listed below.

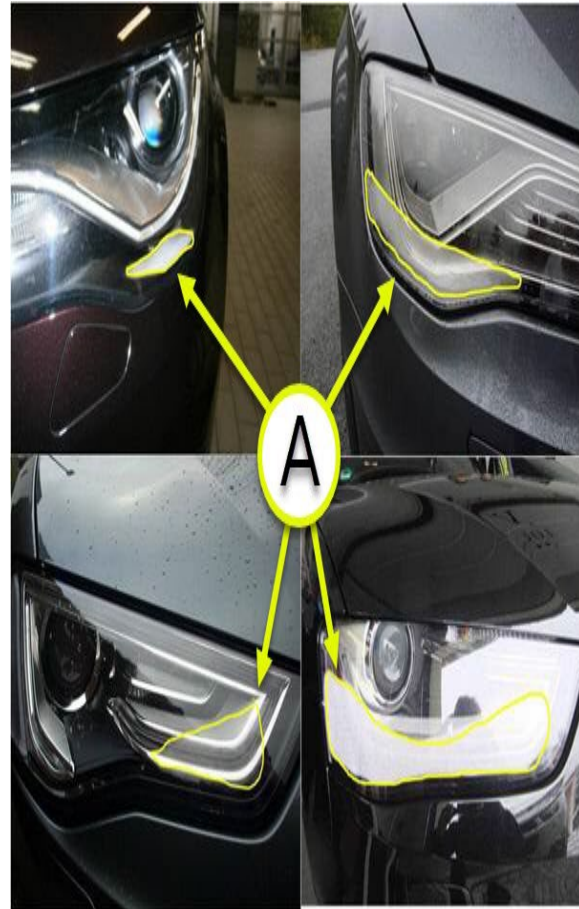
- Workshop is able to confirm the customer concern. **Figure 1** provides examples of **NORMAL** amounts of moisture that may be visible. The level of moisture buildup may vary car-to-car or even between lamps on the same vehicle.

Figure 1. Normal condensation/moisture on the inside of the lights.

If the amount of moisture/condensation is deemed normal please explain this to the customer. Parts replacement **will not** correct the concern and the customer will likely still experience the same issue.

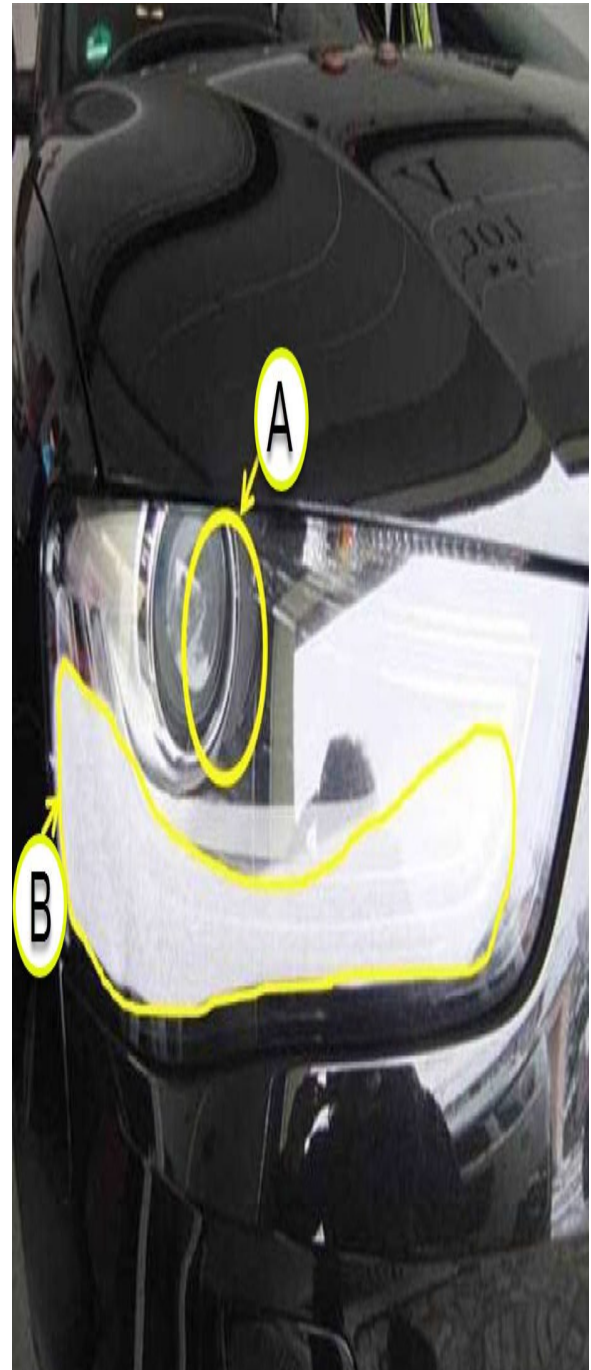
The light emission surface (Figure 2A) of the main beam should be clear after driving for approximately 10 minutes with the main beam on.

- Driving speeds must be consistently over 45mph for the ventilation system to properly function.
- Residual condensation (Figure 2B) may be present depending on ambient conditions, this is normal.
- The amount of time required for the condensation to clear will depend on the outside temperature, relative humidity, and the vehicle speed (higher speeds provide better ventilation).
- Leaving a vehicle stationary with lamps on is **NOT** sufficient for clearing moisture

Figure 2. A: Main beam light emission surface. B: Condensation of the headlamp.

If water drops or condensation are present on the light emission surface (Figure 2A) after performing step one, inspect the headlamp assembly for the root cause:

- Missing cover.

- Damaged seal.
- Clogged drain.
- Outside influence.
- Vent tube disconnected from the headlamp.

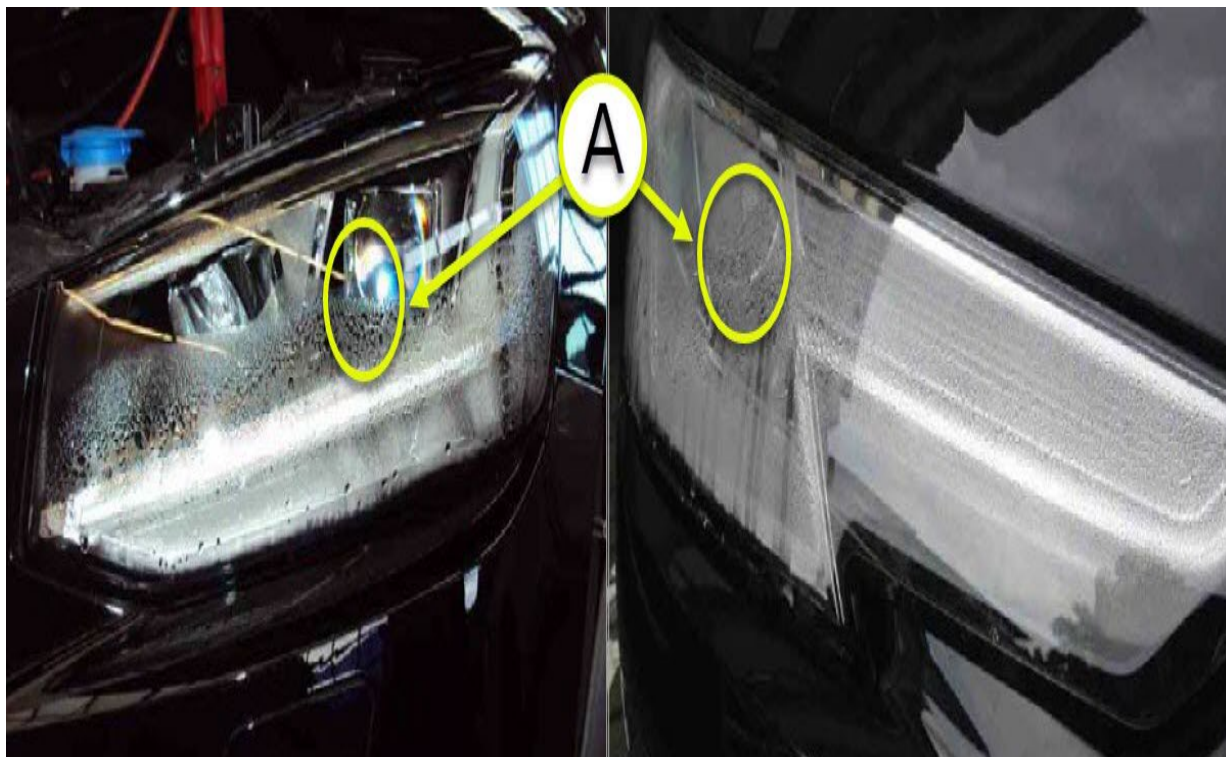
Abnormal amounts of moisture can be seen in figures 3 and 4 below. These are examples of excessive moisture still present **AFTER a thorough test drive** with lamps on.

Figure 3. A: Example of a compromised headlamp. Moisture is still present in the light emission surface after a test drive.

When submitting a claim under warranty, please upload the photos to **DOC-IT** for review. Claims submitted without photos may be charged back.

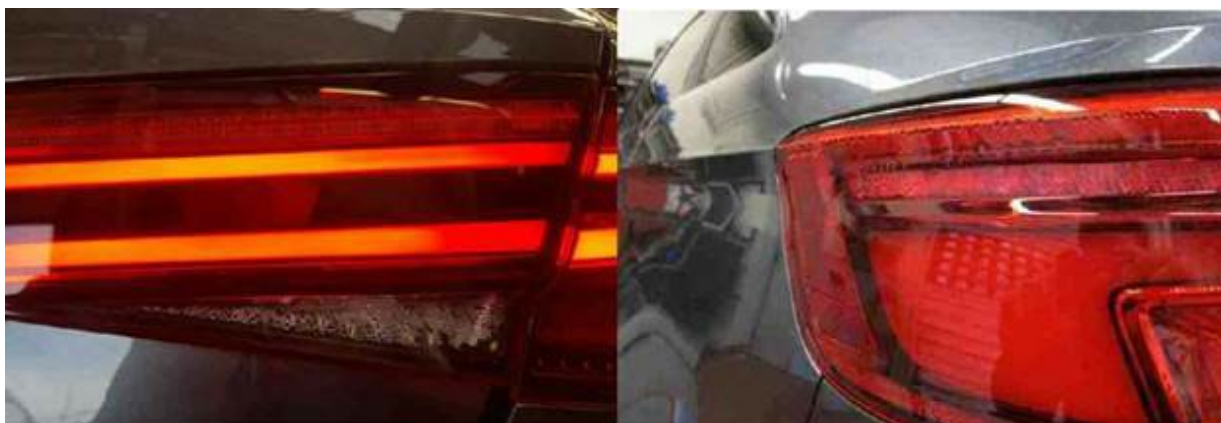
Figure 4: Example of compromised tail lamps after a sufficient test drive.
