SIB 26 04 22

## WHISTLING NOISE 30 – 37 MPH WITH LOW OUTSIDE TEMPERATURES

This Service Information Bulletin (Revision #1) replaces SI B26 04 22 **dated December 2022**.

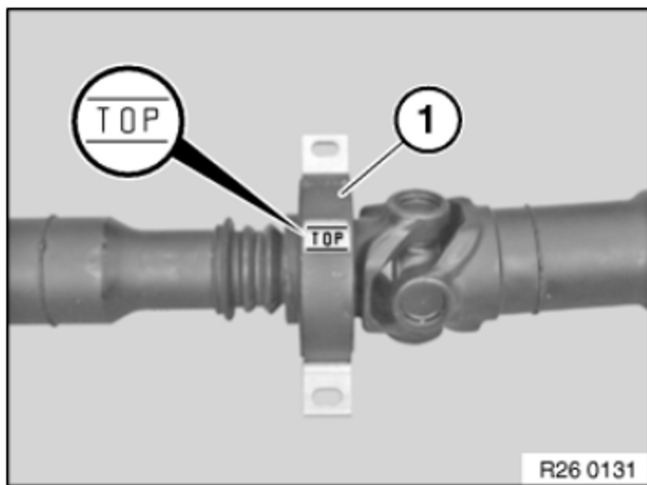
**NOTE:** The “TOP” designation on the center bearing points upwards towards the transmission tunnel.

Replace the center bearing.

Follow Repair Instruction **26 12 001 “Replacing the complete propeller shaft center bearing”**.
