Service Update

N222385700 Main Body Wiring Harness (MBWH) Making Contact With Mounting Stud

Release Date: May 2023

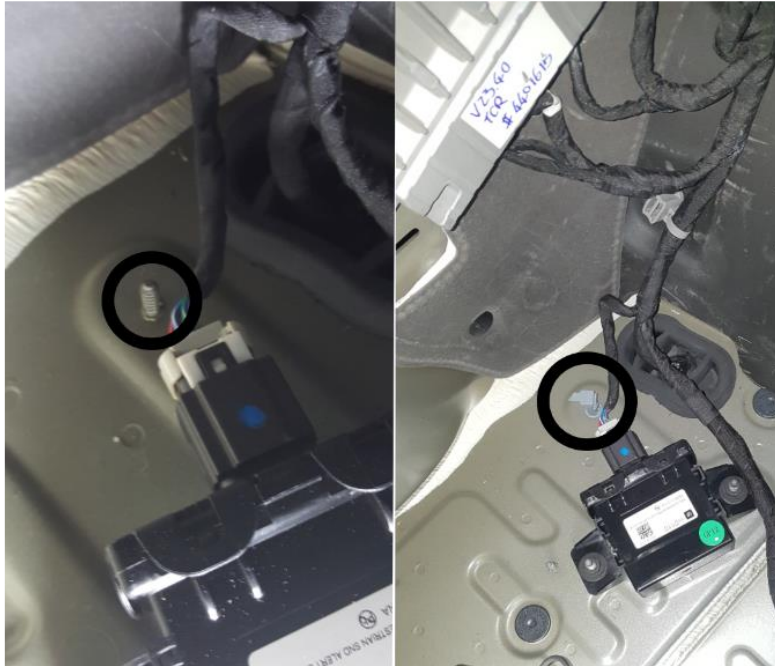
6224053

Condition	Certain 2023 model year Cadillac LYRIQ vehicles may have a condition where the main body wiring harness (MBWH) could be abraded by a mounting stud.
Correction	Dealers will install a clip to the MBWH to prevent damage from the mounting stud.

2. Locate the stud near the module shown under the Quarter Lower Rear Trim Panel. Clip the entirety of the zip tie off the body harness stud clip, then install the clip over the stud to protect the wiring harness.
3. Reinstall the Quarter Lower Rear Trim Panel. Refer to *Quarter Lower Rear Trim Panel Replacement - Left Side* in SI.
