19 loss of coolant from coolant pump - V6 TFSI

19 23 39 2070349/1 May 17, 2023.

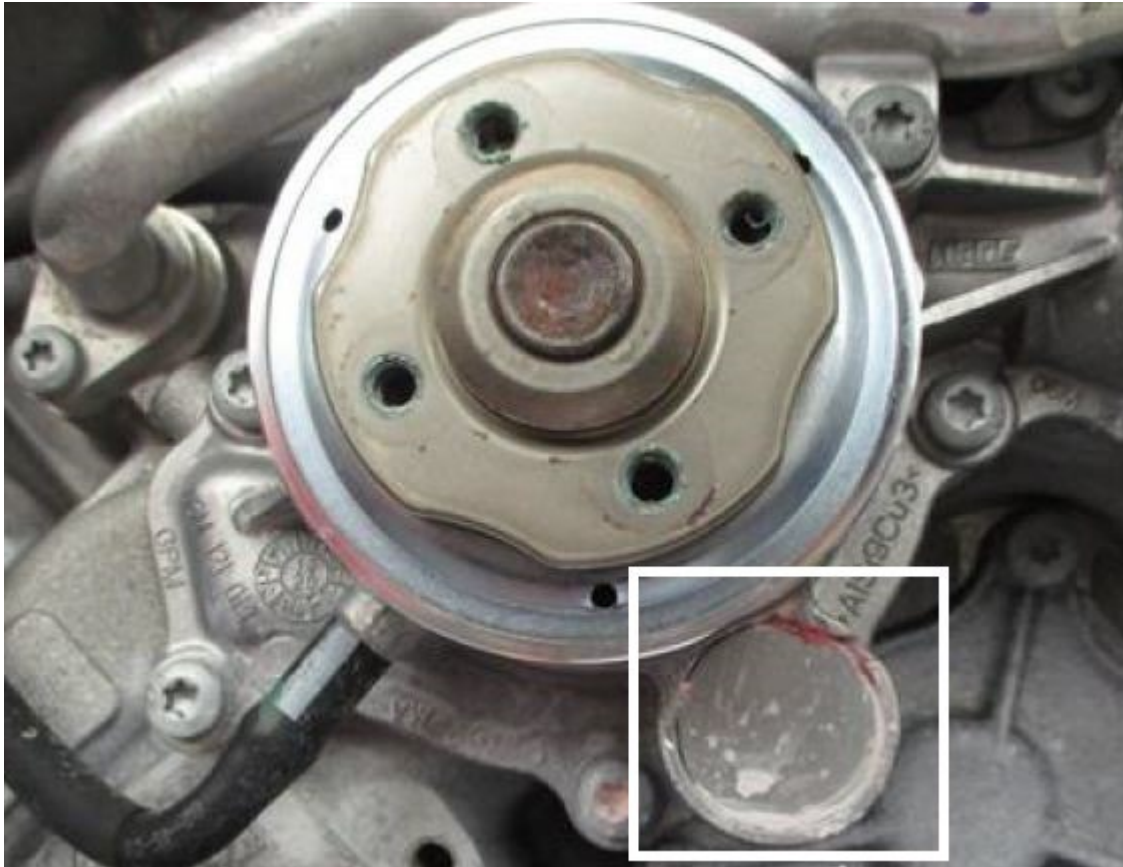
Traces of coolant (small quantity) on drip cup (refer to figure 1).

Due to lubrication/cooling of the seal, up to 3 ml may escape over the course of 100 hours of operation. This is quite normal and does not constitute a reason for a complaint.

Figure 1: Traces of coolant on the drip cup.
