# TECHNICAL SERVICE BULLETIN

## Door(s) Do Not Open From The Exterior Handle

**23-2156**

<b>Ford</b> 2021-2023 Bronco Sport
2020-2023 Escape
2022-2023 Maverick
<b>Lincoln</b> 2020-2023 Corsair

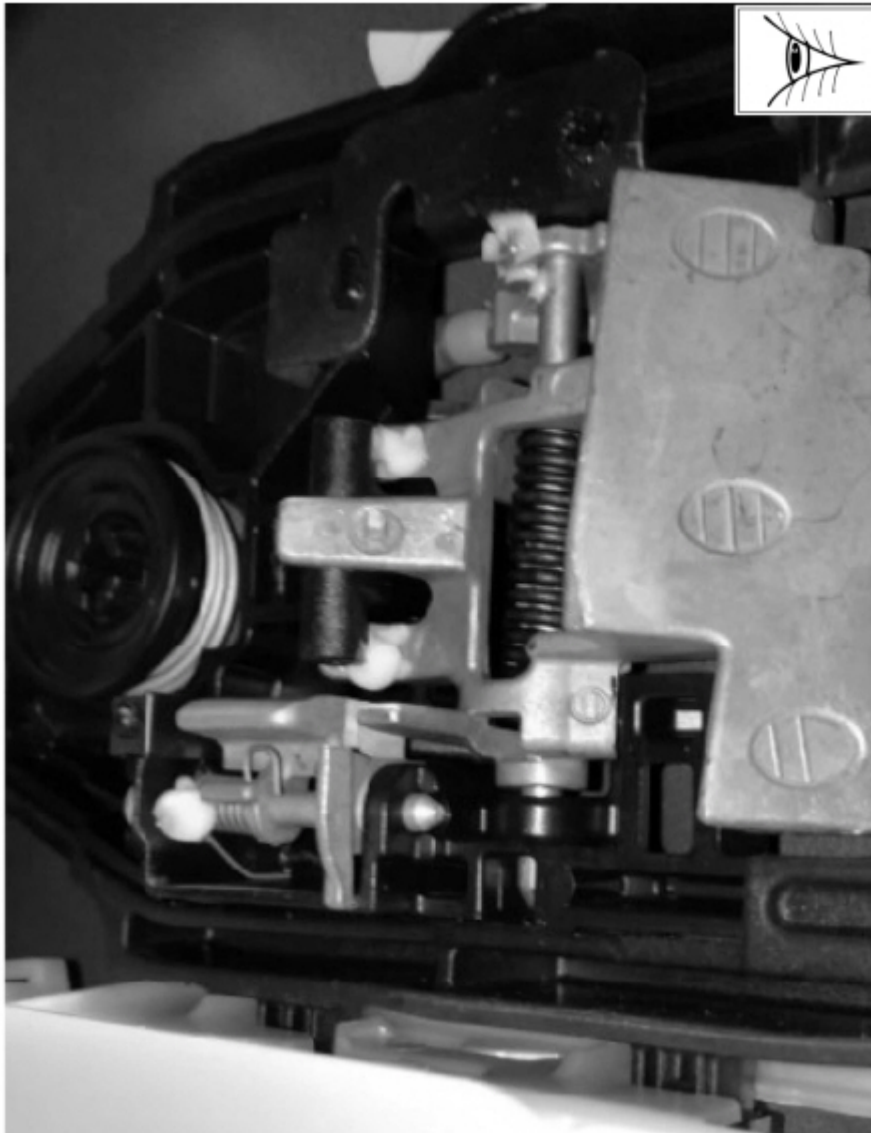
Figure 1

3. Inspect the exterior door handle reinforcement for permanent engagement inertia lock clip engaged and the inertia lock rotated outboard (Figures 1-2). Is the inertia lock rotated outboard and the permanent engagement inertia lock clip engaged?

4. Use a small flat head screwdriver to depress the permanent engagement inertia lock clip and allow the inertia lock to rotate inboard to the rest position. (Figures 3-4).
