# Technical Service Bulletin

## 40 Cracking noise from front end when changing direction

40 23 55 2061464/4 May 9, 2023. Supersedes Technical Service Bulletin Group 40 number 22-43 dated June 9, 2022, for reasons listed below.

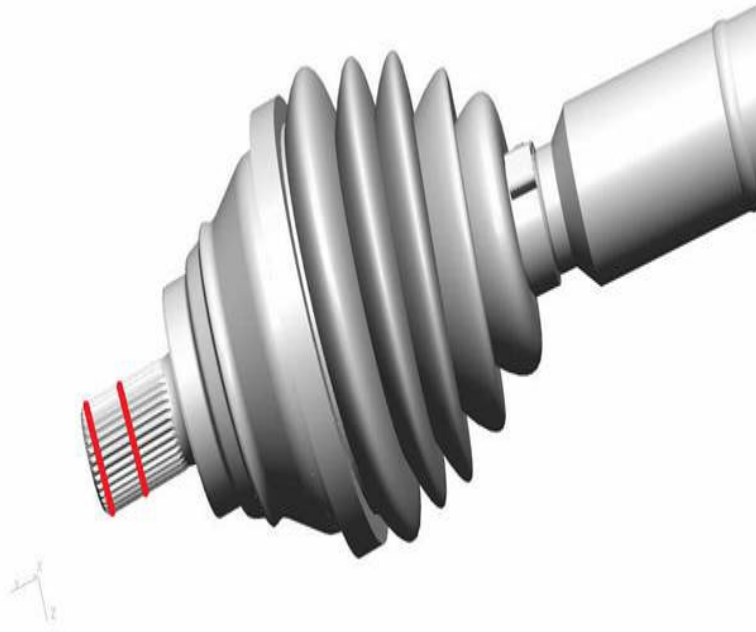
- When pulling away there is a one-off cracking noise from the front after changing direction.

Relative movement of the drive axle in the wheel bearings.

**Figure 1.** Apply locking fluid around the threaded connection.

1. Follow instructions according to Elsa at Repair Manual, *Chassis >> Suspension, Wheels, Steering >> 40 Front Suspension >> Front Axle >> Drive Axle >> Drive Axle Disassembling, Assembling.*
2. Disassemble the affected drive axle.
3. Apply liquid locking fluid as shown in Figure 1 (red lines around the threaded connection).

4. Reinstall the drive axle according to ELSA instructions.

**After assembling the drive axle(s), the vehicle must not be operated for 8 hours.**
