Technical Service Bulletin

69 Airbag control module test plans not completing, B130455, B130555, B159B00

69 23 89 2070322/1 May 19, 2023.

Model(s)	Year	VIN Range	Vehicle-Specific Equipment
A3, S3, and RS 3	2022 – 2023	All	Not Applicable

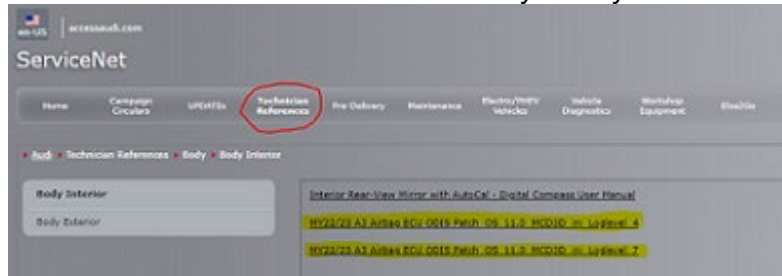
Figure 1. Both of the ODIS patch files are located in ServiceNet.

1. If a configuration of the airbag control module fails (e.g. after replacing a front seat belt), perform an ignition cycle. Interrogate the airbag control module fault memory again, and attempt to run the test plans again.
2. If they still fail, use the oldest possible hardware version of the diagnostic tester (e.g. VAS6150D) and start diagnosis again.
3. If the configuration is still unsuccessful, an ODIS patch needs to be installed to ensure proper communication with the airbag control module. This ODIS patch consists of two files which are available in ServiceNet (Figure 1):

ServiceNet>>Technician References>>Body>>Body Interior.
