STAR ONLINE PUBLICATION

Case Number: S2321000003

Release Date: April 2023

Symptom/Vehicle Issue: Malfunction Indicator Lamp (MIL) Illumination. Diagnostic Trouble Codes (DTCs) P0882 – TCM Power Input Signal Low, or P0883 – TCM Power Input Signal High, set.

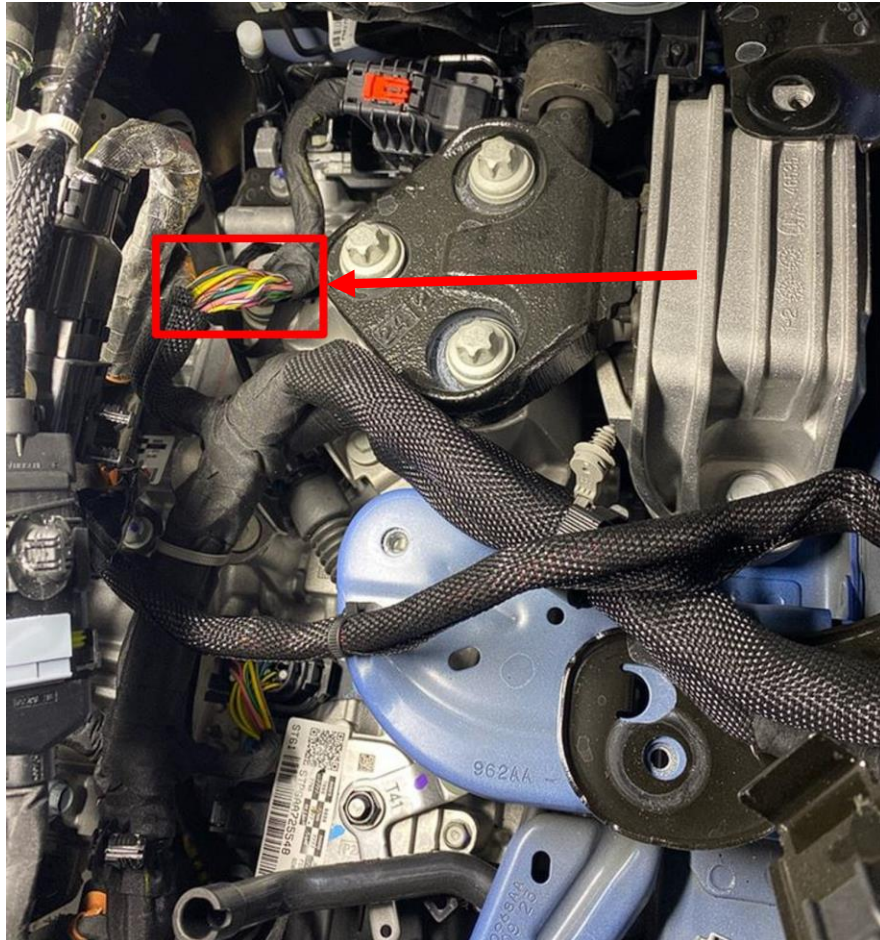
Figure 1

1. Remove the battery tray. Refer to detailed repair procedures in Service Library Service Information section 08 – Electrical > 8F - Engine Systems > Battery > Tray, Battery > Removal and Installation.
2. Inspect the Headlamp to Dash harness where it passes over the PCM and PCM mounting bracket for damaged/cut wiring, due to it rubbing on the PCM. Please see **(Figure 1)**.

NOTE: It may be necessary to remove the protective tape/covering from the harness to see the damaged/cut wiring.

NOTE: Harness covering removed for better visual representation.

3. Repair all damaged/cut wiring. Refer to detailed repair procedures in Service Library Service Information section 28 – DTC Based Diagnostics > Circuit Testing Procedures > Standard Procedure > Wire Splicing.
4. Install 2 pieces of foil backed sealing tape, Mopar part number 05160288AA or equivalent, onto the edge of the PCM where the harness runs over it, to protect the harness against further damage. Please see (**Figure 2**).
