STAR ONLINE PUBLICATION

Case Number: S2008000132 - Rev. D

Symptom/Vehicle Issue: Malfunction Indicator Lamp Illuminated. U11E9 Lost Communication With AGS. Ambient Air Temp Incorrectly Displayed. P0070 And P0073 Set For Ambient Air Temp Sensor

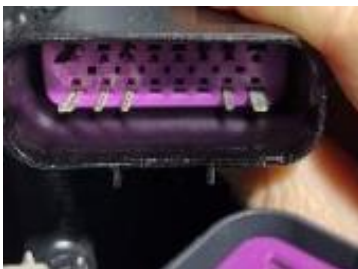
1. Inspect the wiring near the 16-way XY101A Dash to Fascia Connector for nicks and cuts. Also disconnect the connector and inspect for corrosion and terminal pushout.

1. If corrosion, damage, or terminal pushout is present at the XY101A connector. Use connector kit 68497543AA to repair the 16-way Dash side connector and replace the Fascia side harness. A connector repair kit 68500834AA for the fascia side connector is also available. But due to the various possible issues described, fascia harness replacement is recommended.
