<b>REFERENCE:</b>	<b>TSB:</b> 18-048-23 <b>GROUP</b> 18 - Vehicle Performance	<b>Date:</b>	April 15, 2023	<b>REVISION:</b>	18-095-21
<b>VEHICLES AFFECTED:</b>	2012 – <b>**2023**</b> (ALL) (Stellantis Group Gas Vehicles) This bulletin applies to all 2012 - 2023 Stellantis US LLC vehicles with the available wiTECH SLVT.			<b>MARKET APPLICABILITY:</b>	
				<input checked="" type="checkbox"/> NA	<input type="checkbox"/> MEA
				<input type="checkbox"/> SA	<input type="checkbox"/> IAP
				<input type="checkbox"/> EE	<input type="checkbox"/> CH

This bulletin supersedes Technical Service Bulletin (TSB) 18-095-21, date of issue December 17, 2021, which should be removed from your files. All revisions are highlighted with **\*\*asterisks\*\*** and include additional model years and discussion points.

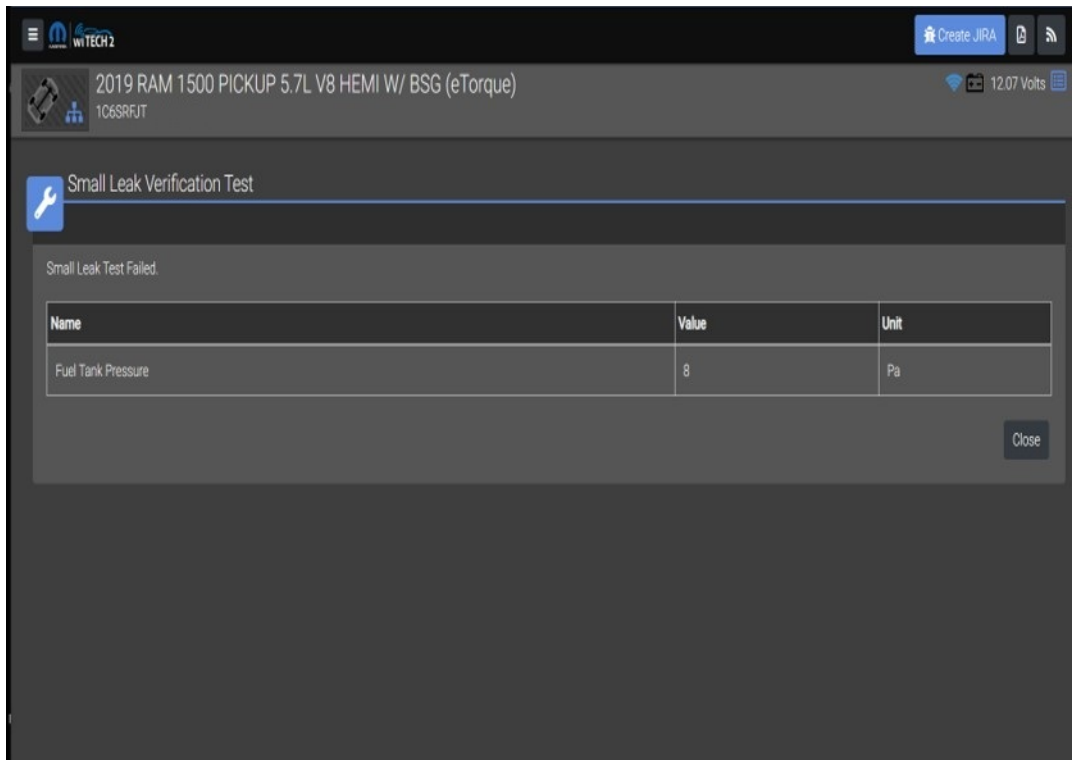
**Fig. 1**  
**Failed Test Screen**

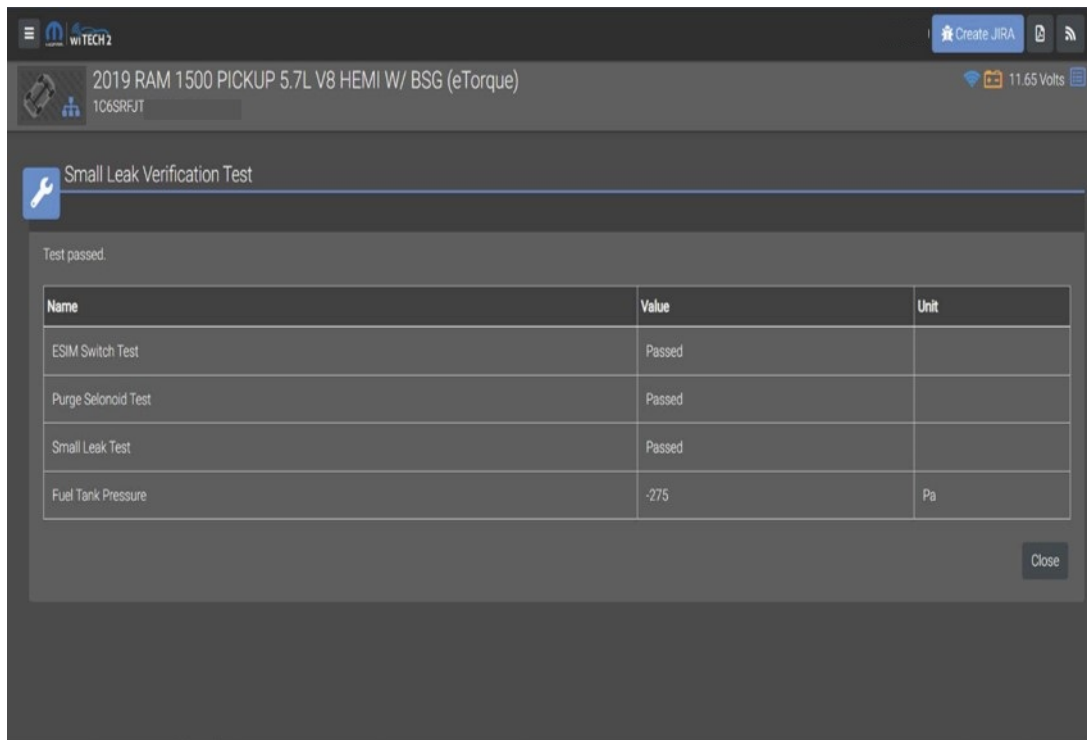
**Fig. 2**  
**Passed Test Screen**
