**Technical Service Bulletin (TSB)**  
**Diesel Exhaust Fluid (DEF) Fluid Freezing**

<b>REFERENCE:</b>	<b>TSB:</b> 14-003-23 <b>GROUP</b> 14 - Fuel System	<b>Date:</b>	April 15, 2023	<b>REVISION:</b>	-
<b>VEHICLES AFFECTED:</b>	<b>2019 - 2022 (DJ) RAM 2500 Pickup</b> <b>2019 - 2022 (D2) RAM 3500 Pickup</b> <b>2019 - 2022 (DD) RAM 3500 Cab Chassis</b> <b>2019 - 2022 (DP) RAM 4500/5500 Cab Chassis</b> This bulletin applies to vehicles equipped with the 6.7L I6 Cummins Turbo Diesel engine (Sales Codes ETL and ETN) or the 6.7L I6 Cummins HO Turbo Diesel engine (Sales Code ETM).			<b>MARKET APPLICABILITY:</b>	
				<input checked="" type="checkbox"/> NA	<input type="checkbox"/> MEA
				<input type="checkbox"/> SA	<input type="checkbox"/> IAP
				<input type="checkbox"/> EE	<input type="checkbox"/> CH
<b>CUSTOMER SYMPTOM:</b>	Customers may experience a Malfunction Indicator Lamp (MIL) illumination. Upon further investigation the technician may find the following Diagnostic Trouble Code (DTC) has been set: <ul style="list-style-type: none"> <li>• P203E-00 - Reductant Level Sensor 1 Circuit Intermittent-Erratic.</li> </ul>

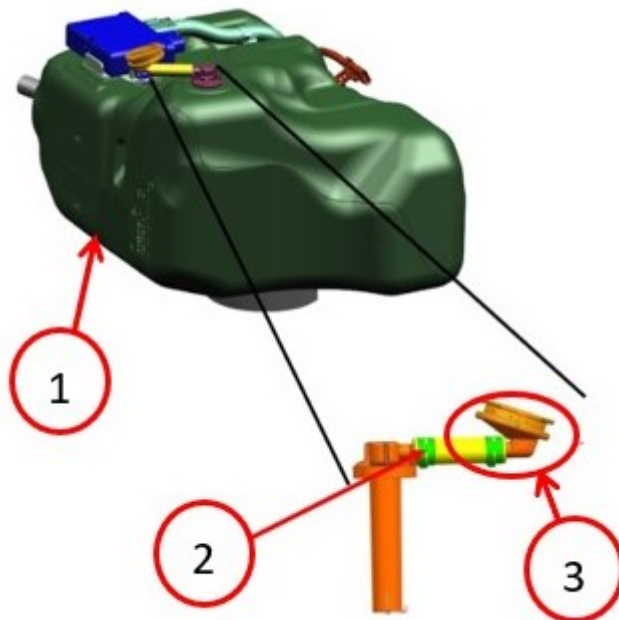
**Fig. 1**  
**DEF Tank Assembly**

- 1 - DEF Tank
  - 2 - Hose Clamp
  - 3 - Grade Vent Valve (GVV)
-

1. Remove the DEF tank. Refer to the detailed service procedures available in DealerCONNECT> Service Library under: Service Info> 25 - Emissions Control / Diesel Exhaust Fluid Emissions / Tank, Diesel Exhaust Fluid / Removal (Fig. 1) .

2. Loosen the hose clamp on the GVV hose and remove the GVV from the DEF tank.
3. Remove and replace the DEF Tank Grade Vent Valve with the new GVV (Fig. 2) .
