**Technical Service Bulletin (TSB)**  
**Incorrect Gear Shift Indicator Console And Armrest Console**  
**Stitching Color**

<b>REFERENCE:</b>	<b>TSB:</b> 23-045-23 <b>GROUP</b> 23 - Body	<b>Date:</b>	April 19, 2023	<b>REVISION:</b>	-
<b>VEHICLES AFFECTED:</b>	2022 (WD) Dodge Durango This bulletin applies to vehicles built on November 29, 2022 (MDH 1129XX) equipped with Orange Accent Stitching (Sales Code MTN) and Suede Wrapped Interior Accents (Sales Code XDA).			<b>MARKET APPLICABILITY:</b>	
				<input checked="" type="checkbox"/> NA	<input type="checkbox"/> CH
				<input checked="" type="checkbox"/> EE	<input type="checkbox"/> IAP
				<input type="checkbox"/> SA	<input type="checkbox"/> MEA
<b>CUSTOMER SYMPTOM:</b>	Gear shift indicator console, bezel and armrest console is wrong color.				
<b>CAUSE:</b>	Incorrect stitching on center console.

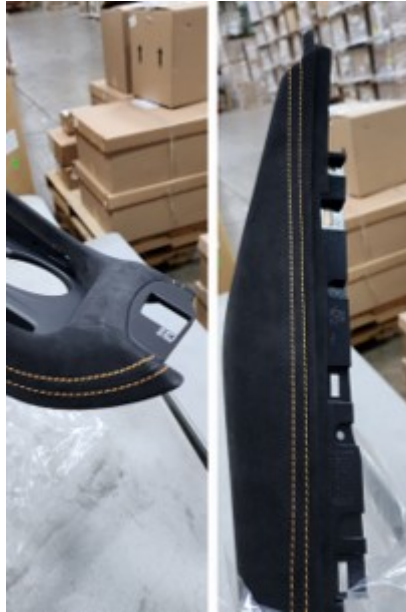
**Fig. 1****Correct Color Stitching (ORANGE)**

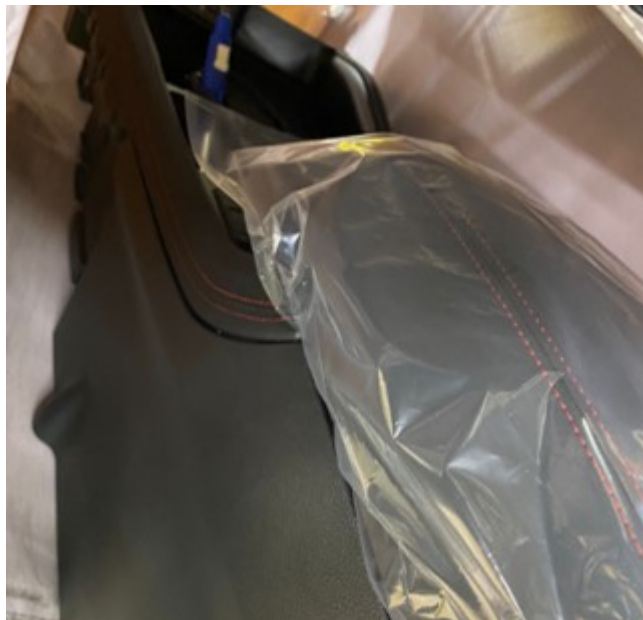
**Fig. 2****Incorrect Color Stitching (RED)**

- YES>>> This bulletin does not apply. Use Inspect LOP (21-75-15-92) to close this active RSU.
  - NO>>> Proceed to [Step 2](#).
2. Replace the center console and bezel. Refer to the detailed service procedures listed in DealerCONNECT> Service Library under: 23 - Body / Interior / Console, Floor / Removal and installation and 23 - Body / Interior / Bezel, Shifter / Removal/ and Installation.
