REFERENCE:	TSB: 08-104-23 GROUP 08 - Electrical	Date:	April 19, 2023	REVISION:	-						
VEHICLES AFFECTED:	<p>2023 (WL) Jeep Grand Cherokee 2023 (WS) Grand Wagoneer/Wagoneer This bulletin applies to vehicles equipped with one of the following radios:</p> <ul style="list-style-type: none"> • Uconnect 5 NAV W 12" Display (Sales Codes UFQ, UBQ or UEQ). • Uconnect 5 NAV W 10.1" Display (Sales Codes UFN, UBN or UEN). • Uconnect 5 W 8.4" Display (Sales Codes UFF, UEF or UBF). • Uconnect 5 Nav W 8.4" Display (Sales Codes UFL, UBL or UEL). <p>This bulletin applies to WL vehicles built on or before February 17, 2023 (MDH 0217XX). This bulletin applies to WS vehicles built on or before February 14, 2023 (MDH 0214XX).</p>			<p>MARKET APPLICABILITY:</p>

CAUSE:	Radio software

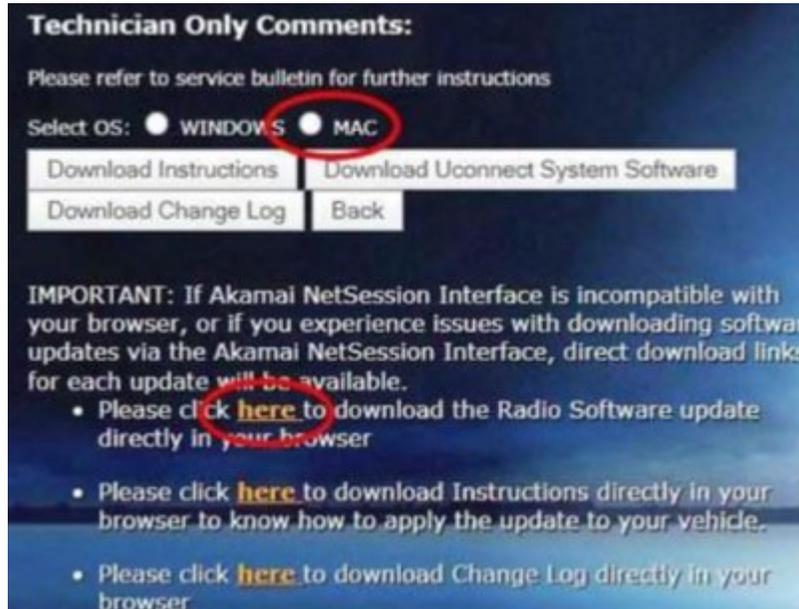
Fig. 1
MAC Download Steps

7. Download the software update file to your local PC's desktop. Make sure to select the "MAC" radial button for all downloads (Fig. 1) .

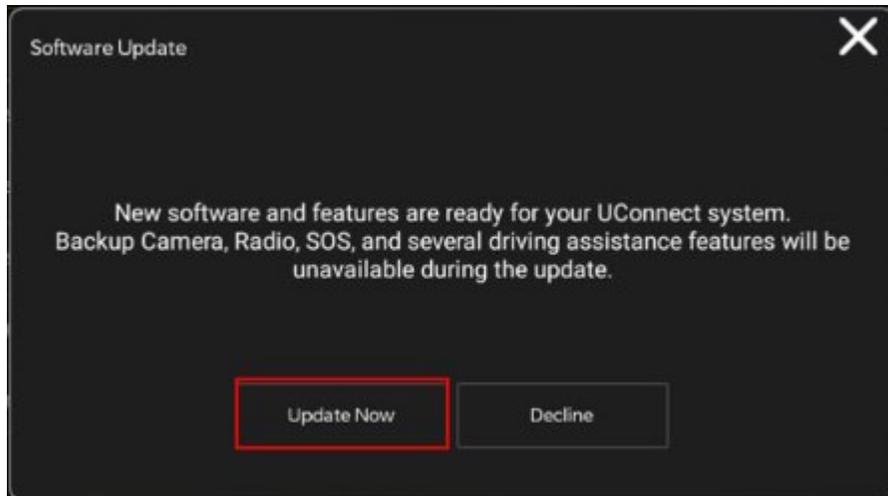
Fig. 2
Software Update Is Available

- Once the system has verified there is an available update, press the "Update Now" button. Make sure the vehicle is in park. **Do NOT turn the ignition off until the two minute timer has expired. The ignition doesn't have to be turned off to update the radio's software (Fig. 2) .**

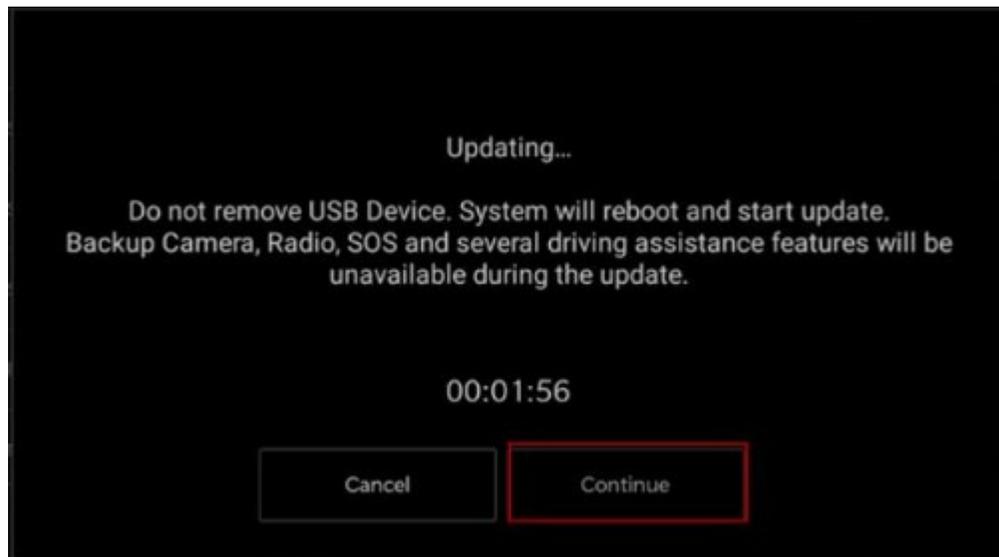
Fig. 3
Continue Display Screen

- Press the "Continue" on the display screen (Fig. 3) .

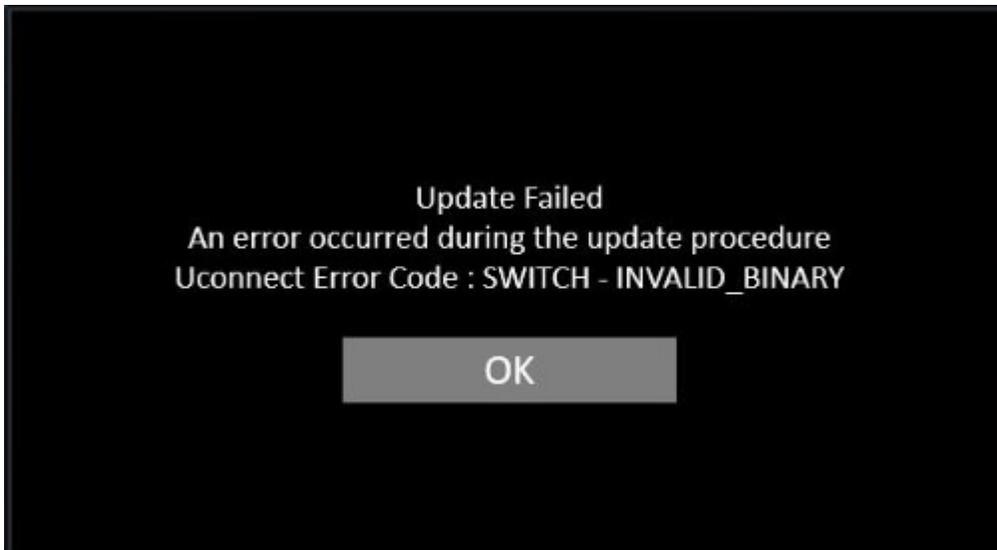
**Fig. 5
Error Message**

16. **Do Not** turn off the ignition at this point. The update is still in process, wait until the radio restarts and the home screen is displayed. This should take around five minutes
17. Sometimes the radio will display an error pop up “ SWITCH - INVALID_BINARY“ after successful radio update. Please ignore this error message and press “OK” to continue (Fig. 5) .

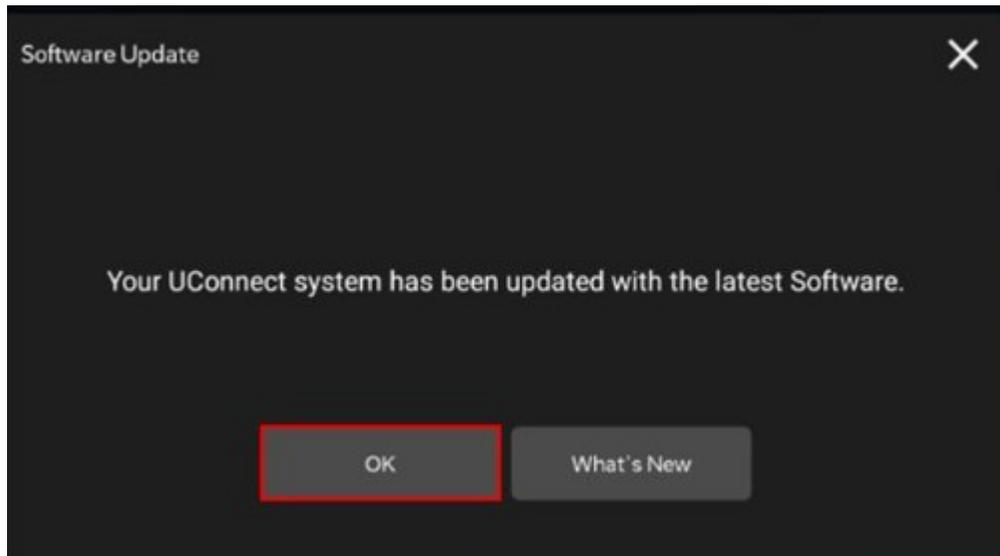
Fig. 6
Radio Software Has Been Updated

18. Press “OK” to continue (Fig. 6) .
