REFERENCE:	TSB: 08-103-23 GROUP 08 - Electrical	Date:	April 19, 2023	REVISION:	—
VEHICLES AFFECTED:	2021 - 2022 (RU) Chrysler Pacifica 2021 - 2022 (WD) Dodge Durango This bulletin applies to vehicles equipped with the following: Global Telematics Box Module (Sales Code RDG).			MARKET APPLICABILITY: <input checked="" type="checkbox"/> NA <input type="checkbox"/> MEA <input type="checkbox"/> SA <input type="checkbox"/> IAP <input type="checkbox"/> EE <input type="checkbox"/> CH	
CUSTOMER SYMPTOM:	Customers may experience one or more of the following: <ul style="list-style-type: none"> • Uconnect pop up box error or requires service message. • Losing WiFi Hotspot streaming connection: internet data is not reliable. • LED blinking on overhead console after ignition cycle. • User is unable to setup the Charge schedule/Climate schedule events in Uconnect App (TBM is sending failure message).

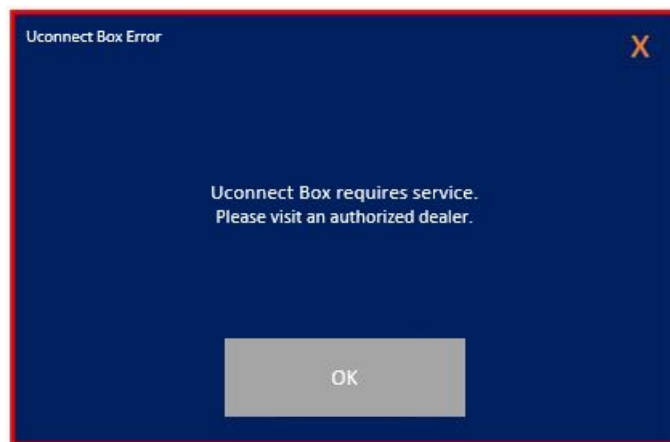
CAUSE:	TBM Software

Fig. 1
Uconnect Box Error Message

Message display on the radio screen, “Uconnect Box requires service. Please visit an authorized dealer.” (Fig. 1) , with no active or stored DTCs set by the TBM.

This bulletin provides information regarding the latest Firmware Over The Air (FOTA) update and provides the service technician an overview of the steps a customer will need to take to complete the update. The TBM software will be updated from (WD - 4.27i.) and (RU - 4.29d) to 4.36.

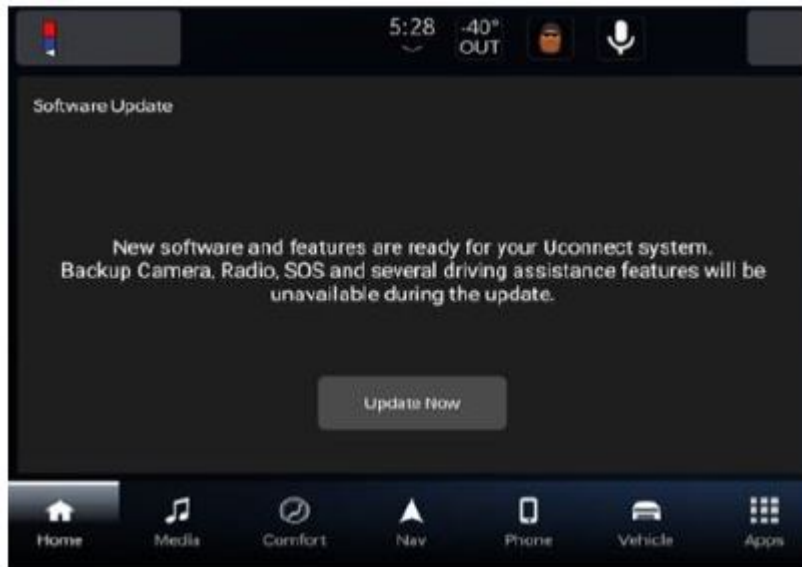
Fig. 2
Software Acceptance Screen

1. The vehicle needs to be in 'Park'. The ignition needs to be in the off position.
2. If the customer selects "Update Now" (Fig. 2) they can shut off the vehicle and leave. The update will be completed automatically.

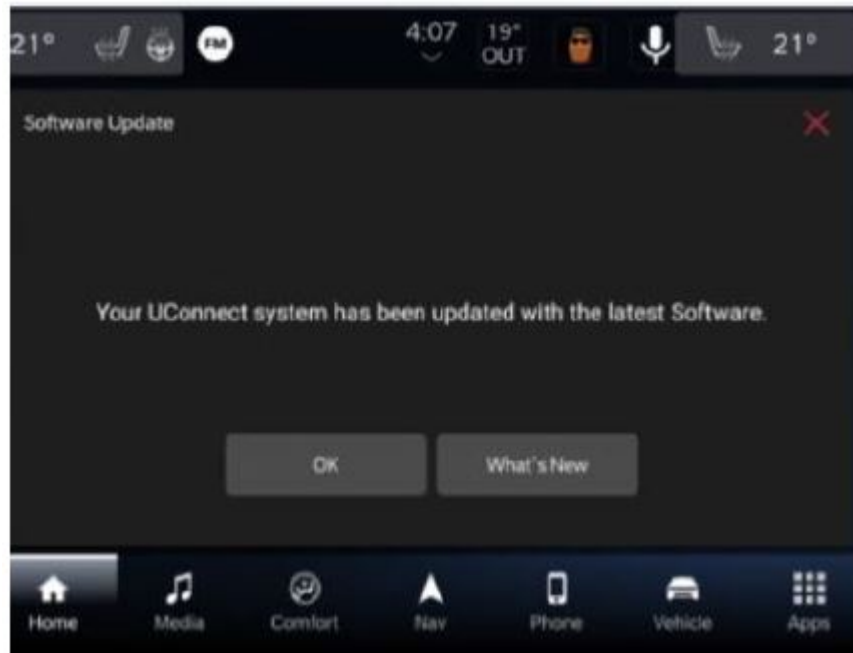
Fig. 3
Software Update Confirmation Screen

3. Upon completion of update, the radio will display a confirmation message (Fig. 3) .
